# Impacts of Increased Tidal Inundation on Coastal Marsh Communities: a case study along Buhne Slough

Emmalien Craydon and Emily Teraoka, Stillwater Sciences

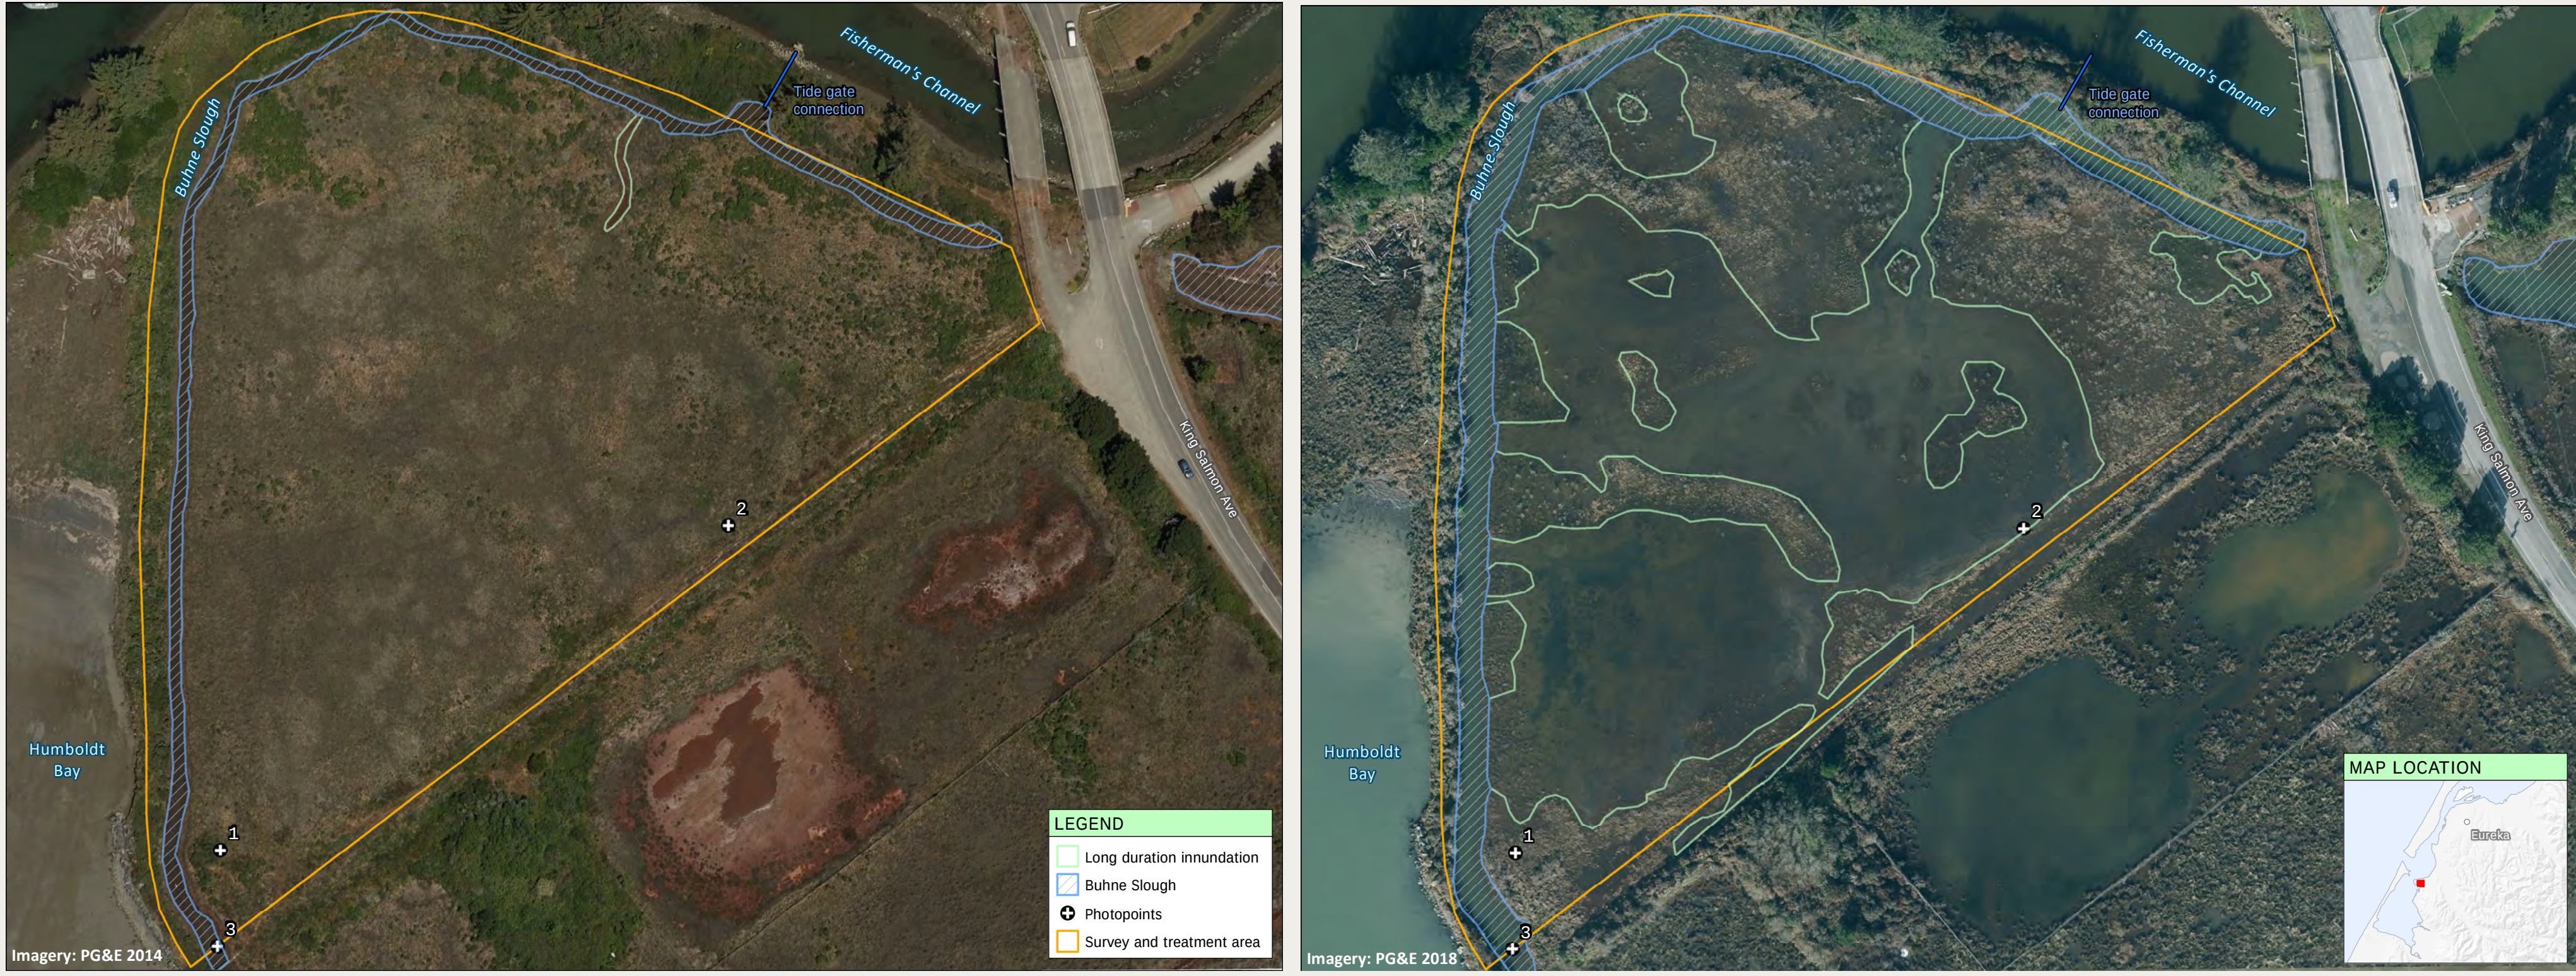
Location of coastal marsh along Buhne Slough and the Fisherman’s Channel-Buhne Slough tide gate connection, King Salmon, CA. The two images illustrate the change in vegetative cover and tidal inundation between 2014 (left) and 2018 (right).

In 2015–2017, *Spartina densiflora* (dense-flowered cord grass) removal efforts occurred in a 2.5-hectare (6.2-acre) intertidal coastal marsh along Buhne Slough in King Salmon, California. The Buhne Slough coastal marsh is former tideland located behind a levee and a tide gate connecting Buhne Slough with Fisherman’s Channel of Humboldt Bay. Vegetative cover data was collected annually from 2015 to 2017 within the coastal marsh to measure the progress of the annual *Spartina densiflora* removal efforts. These annual surveys coincided with the decline and eventual failure of the nearby tide gate in winter 2015/2016. The tide gate failure resulted in an increase in saltwater intrusion and inundation duration on the once tidally-muted marsh as noted by the increased high tide line within Buhne Slough and inudation visible on aerial imagery.

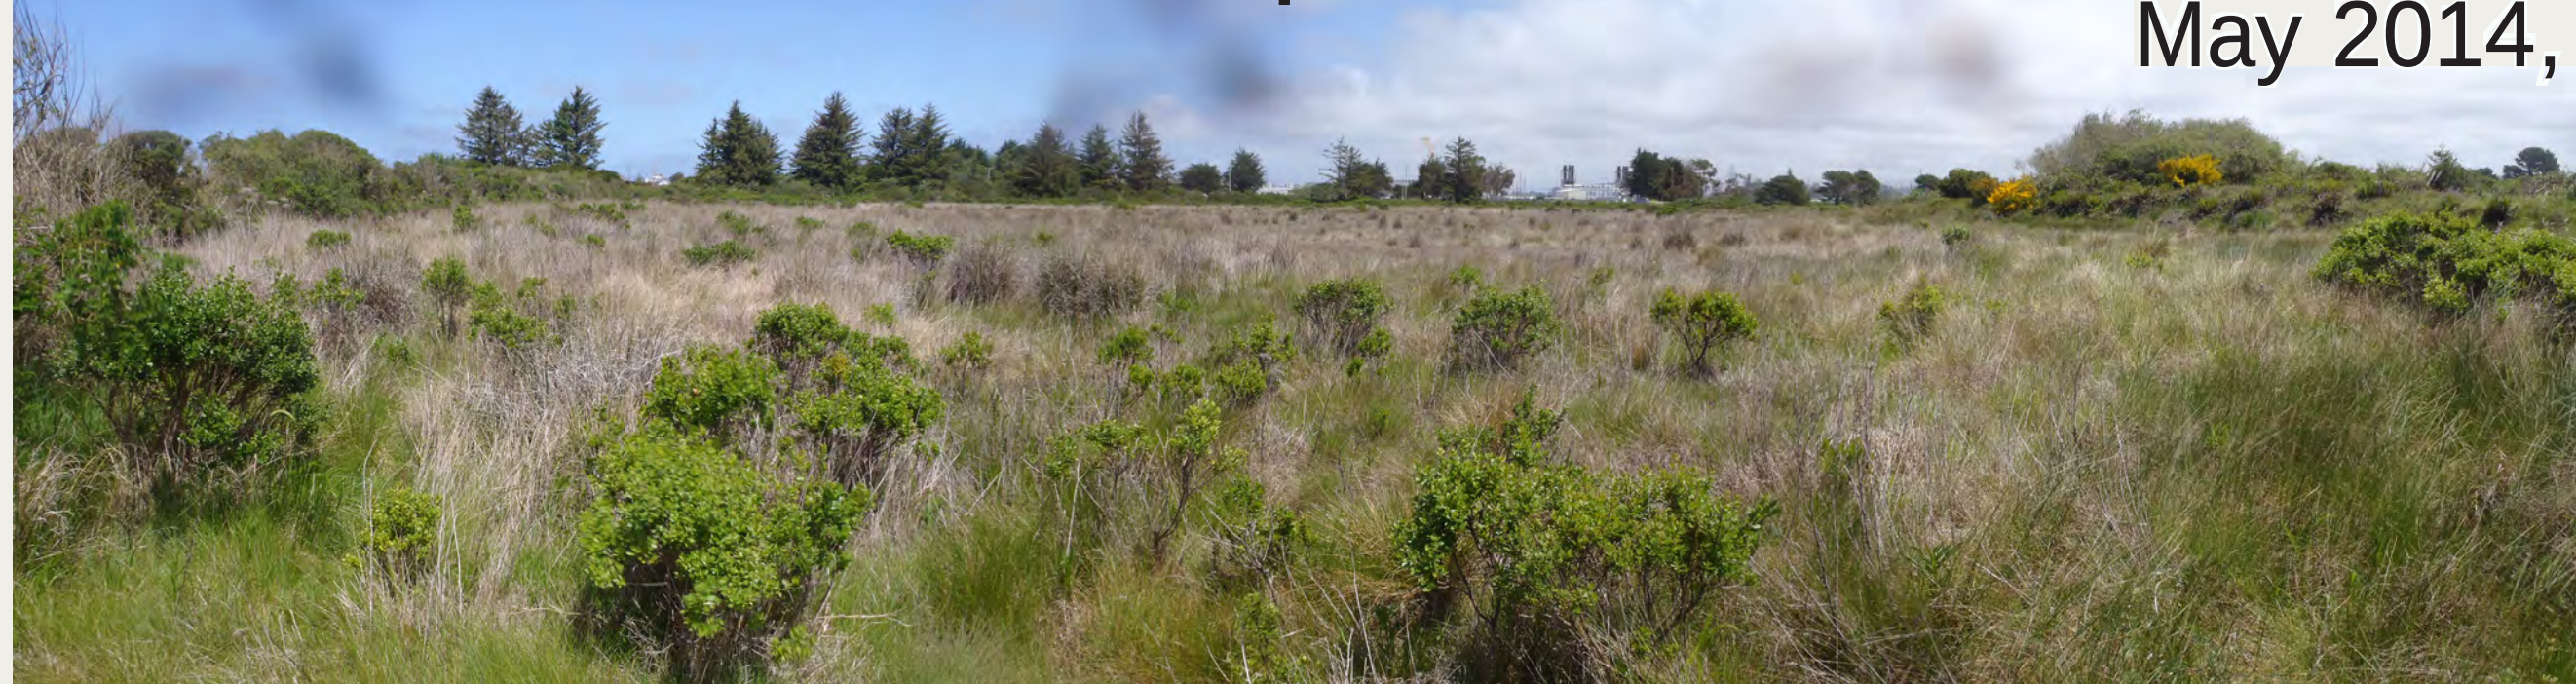
Photopoint 1

May 2014, Tide 0.77 ft

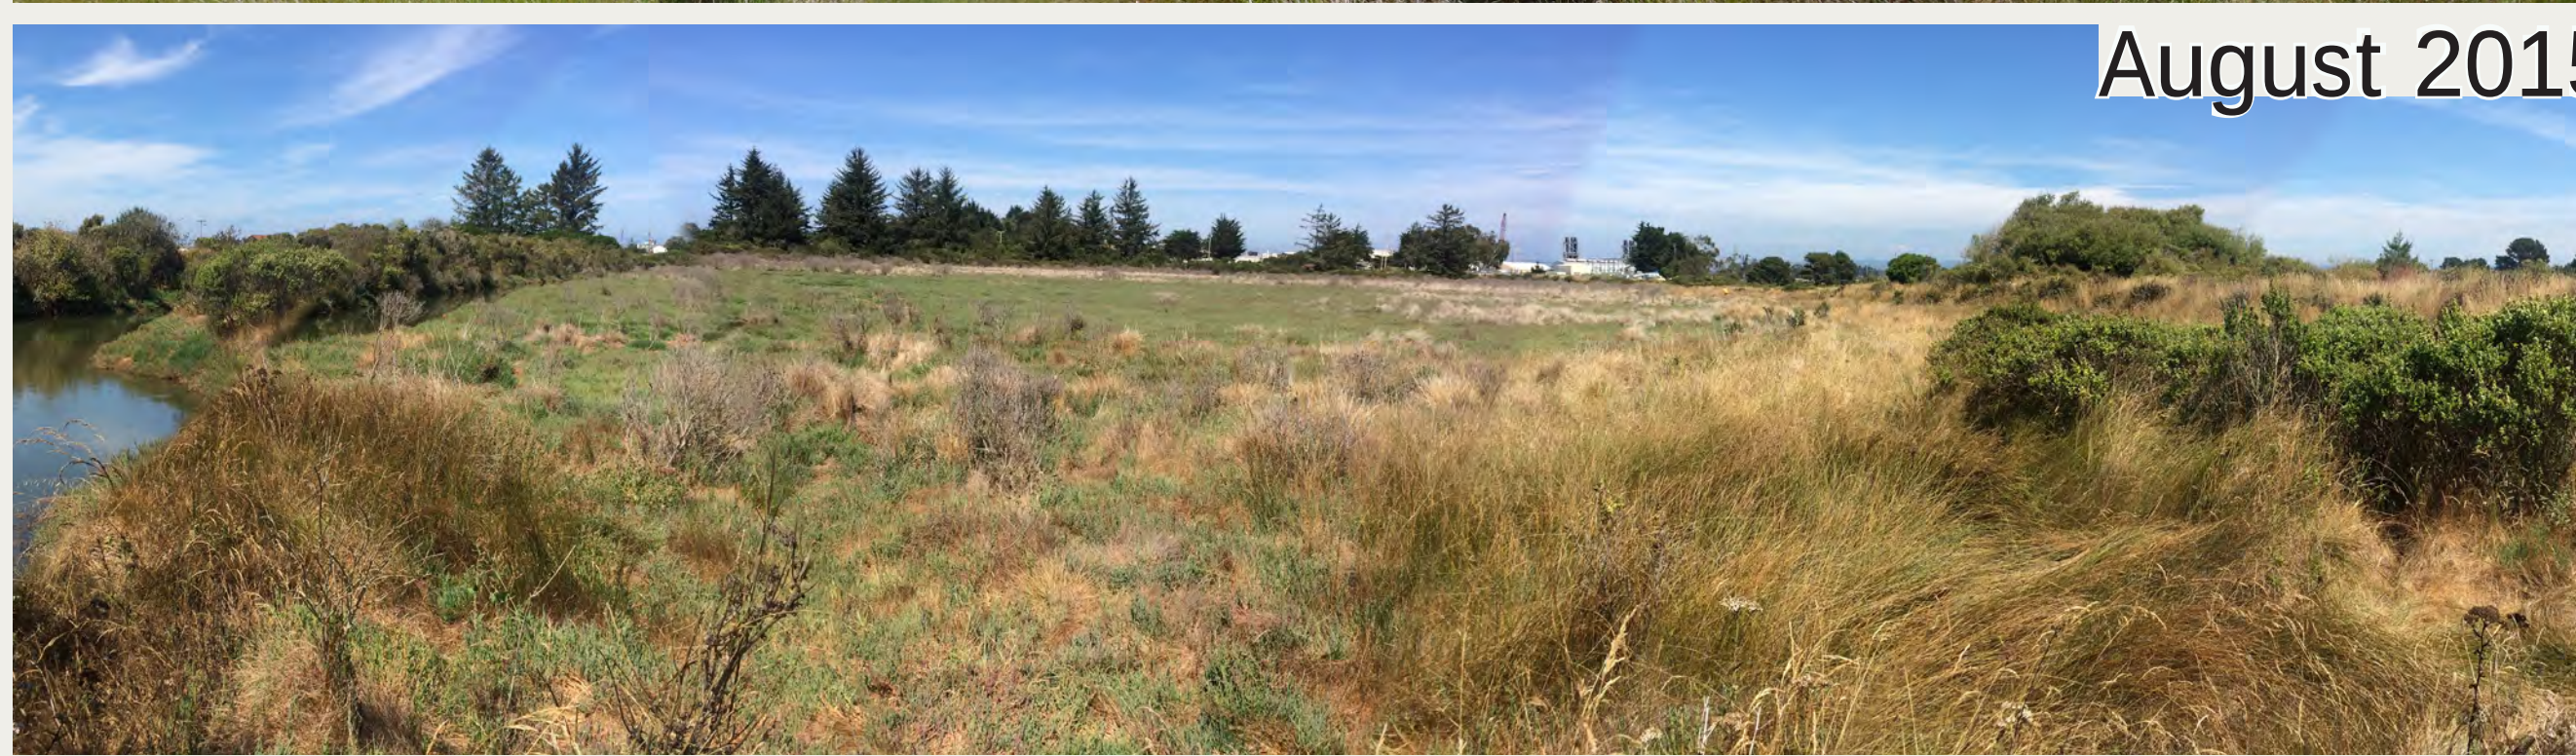
August 2015, Tide 3.1 ft

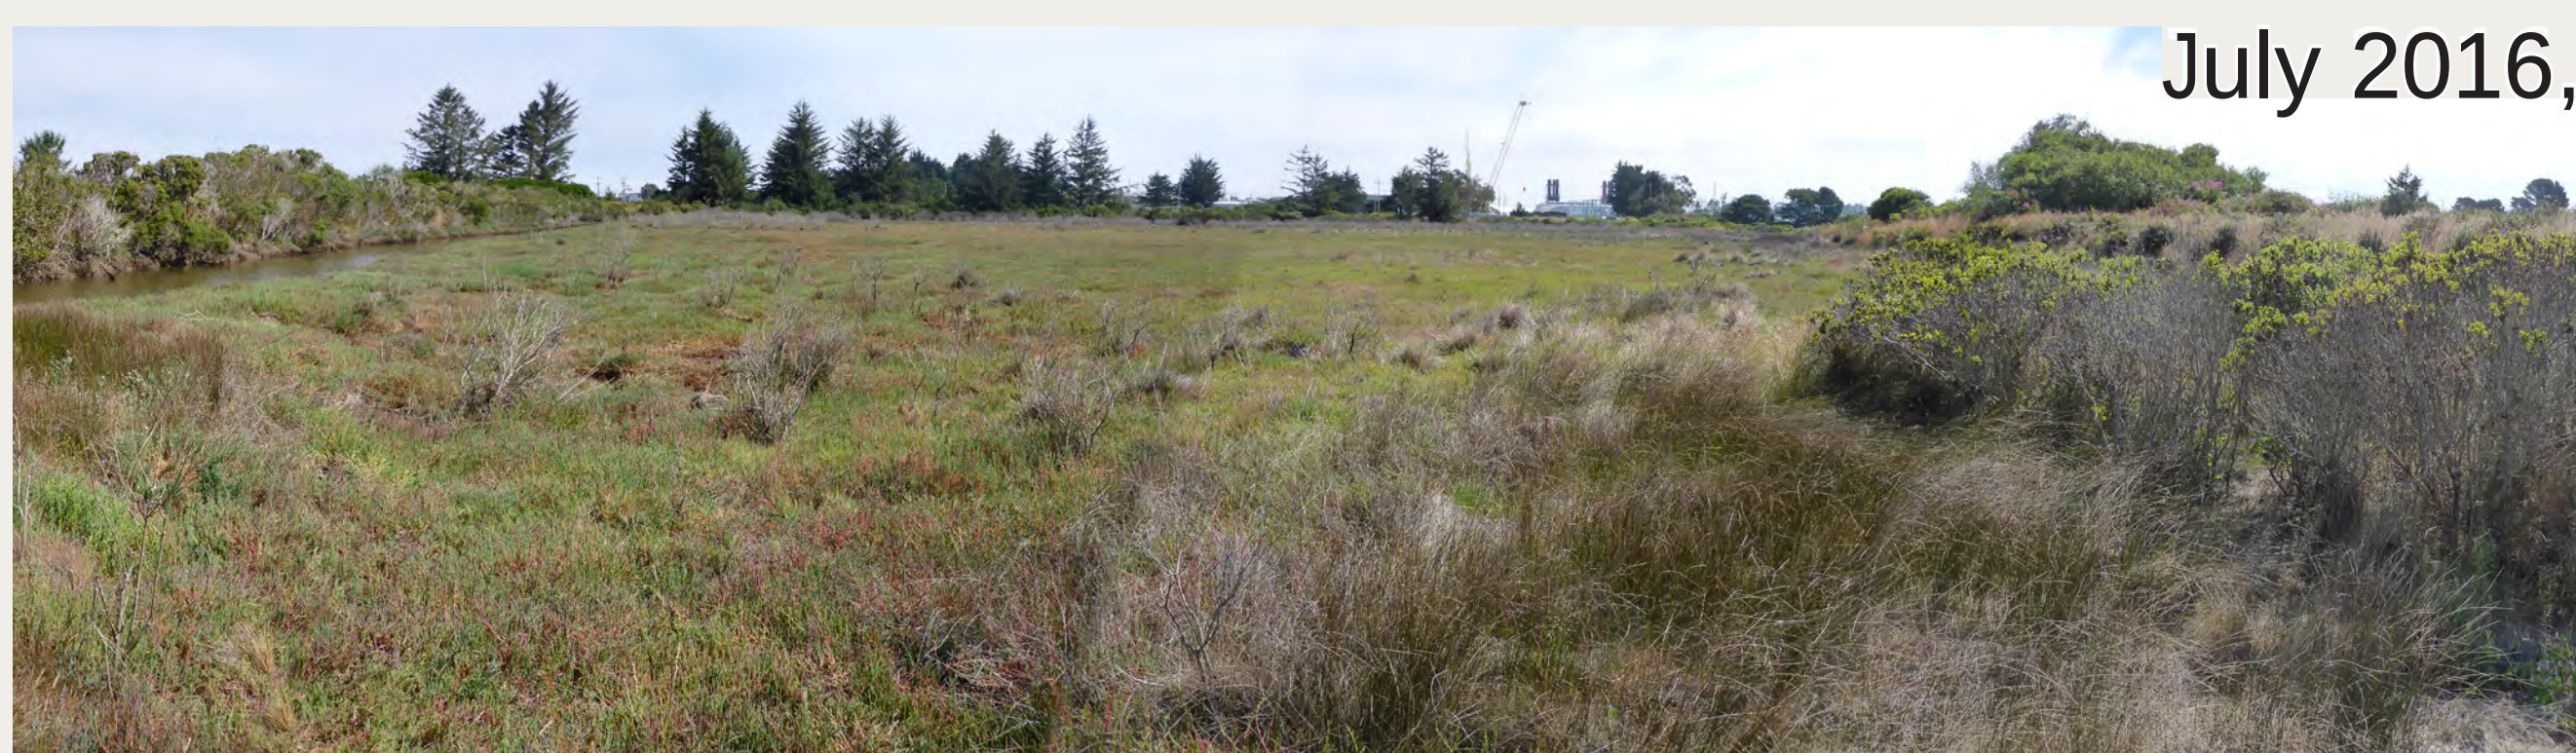
July 2016, Tide 3.7 ft

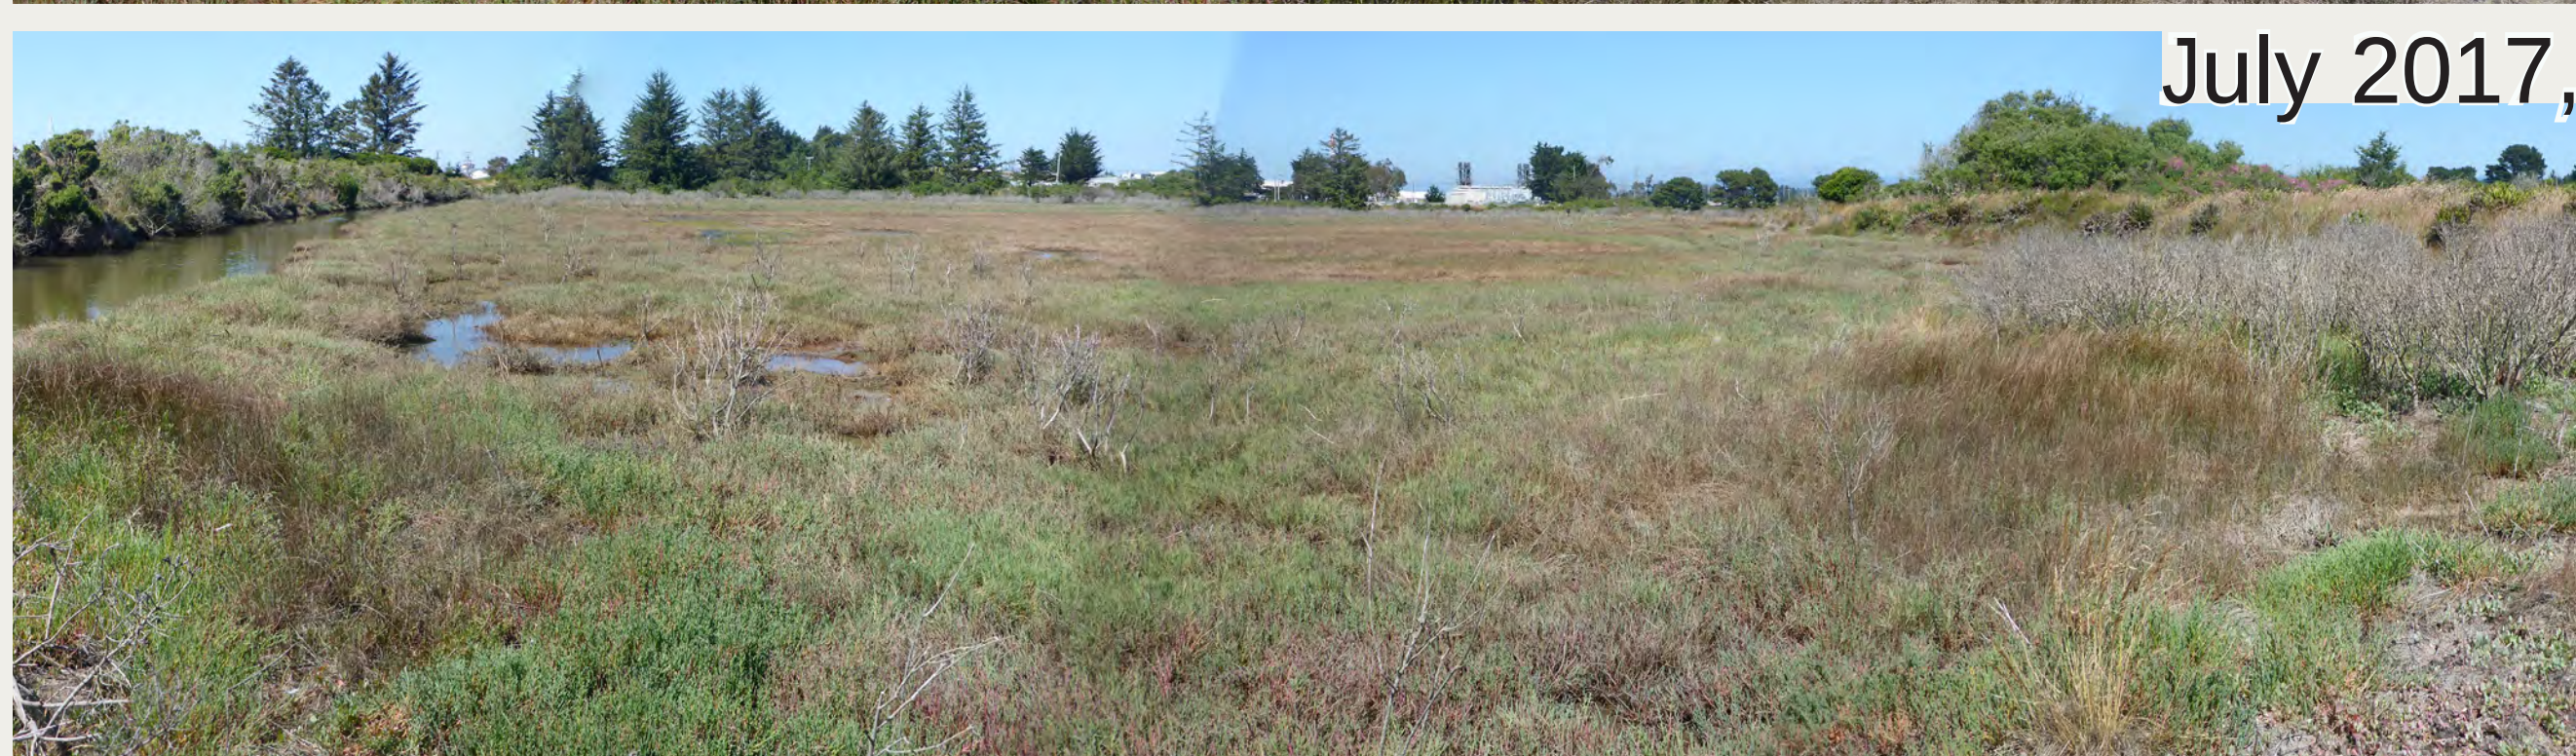
July 2017, Tide 3.4 ft

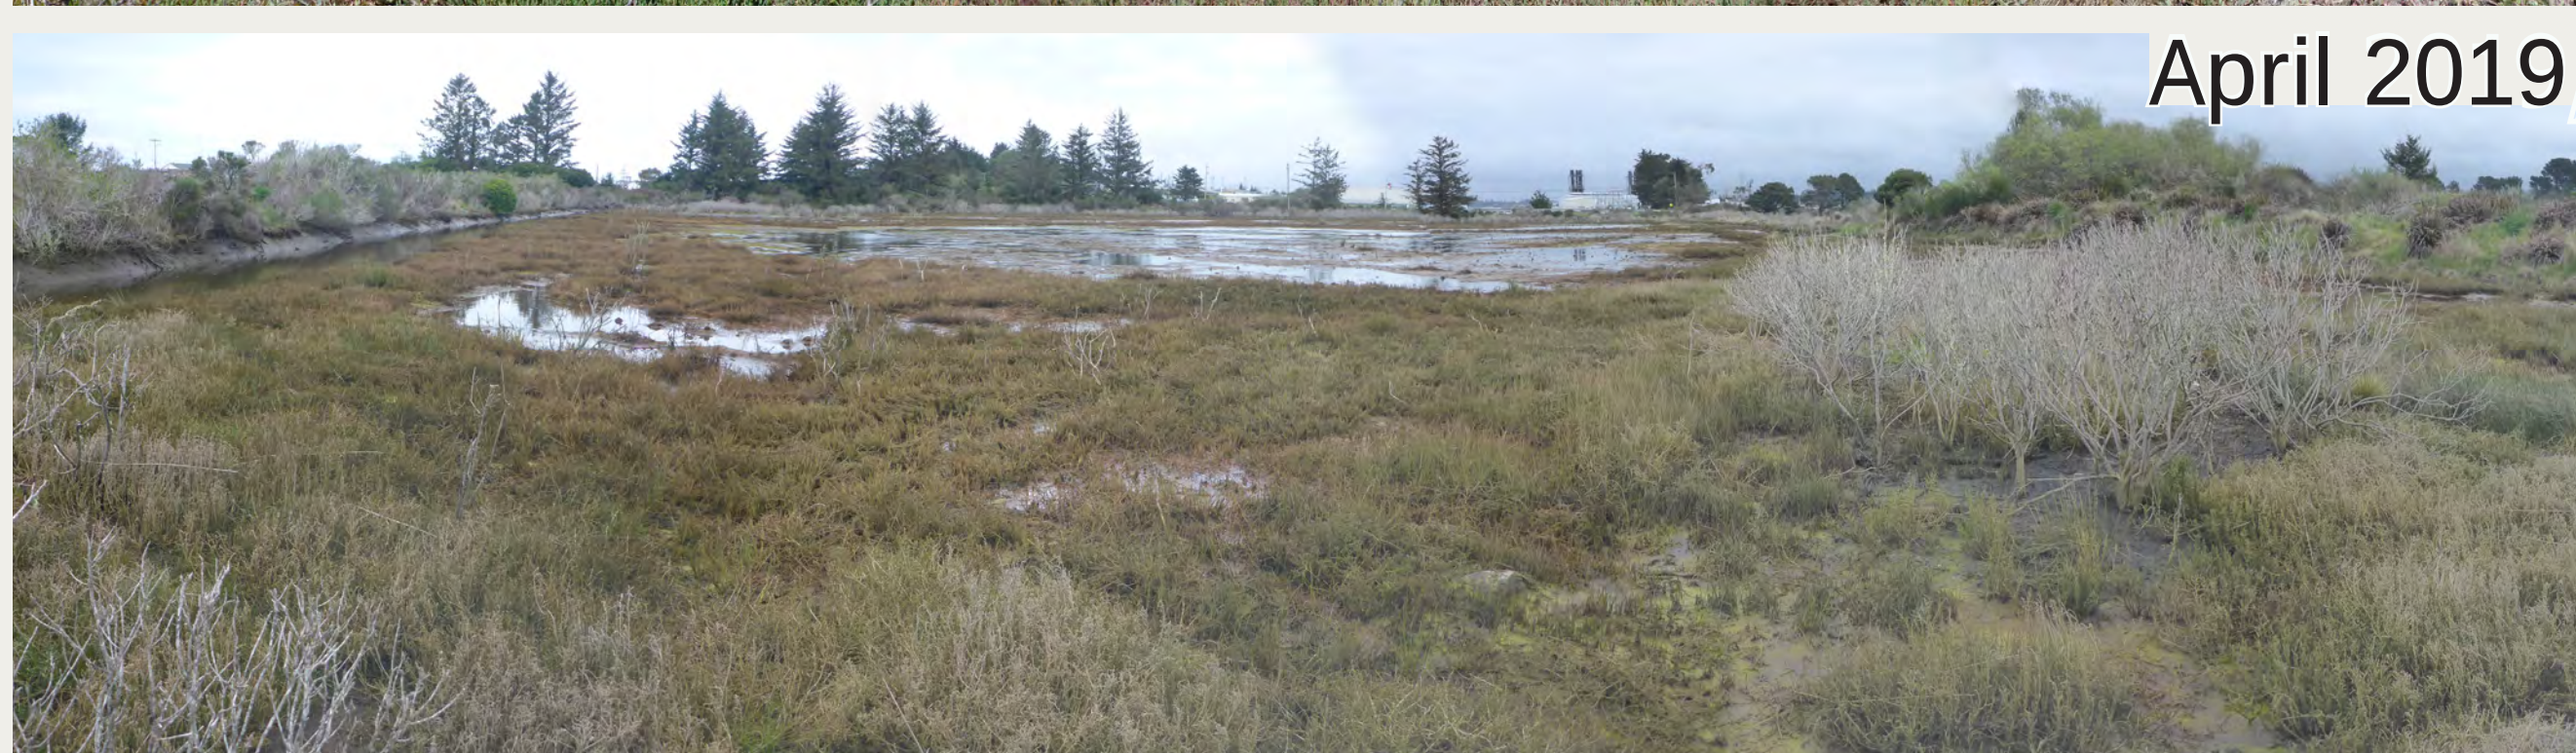
April 2019, Tide 0.5 ft

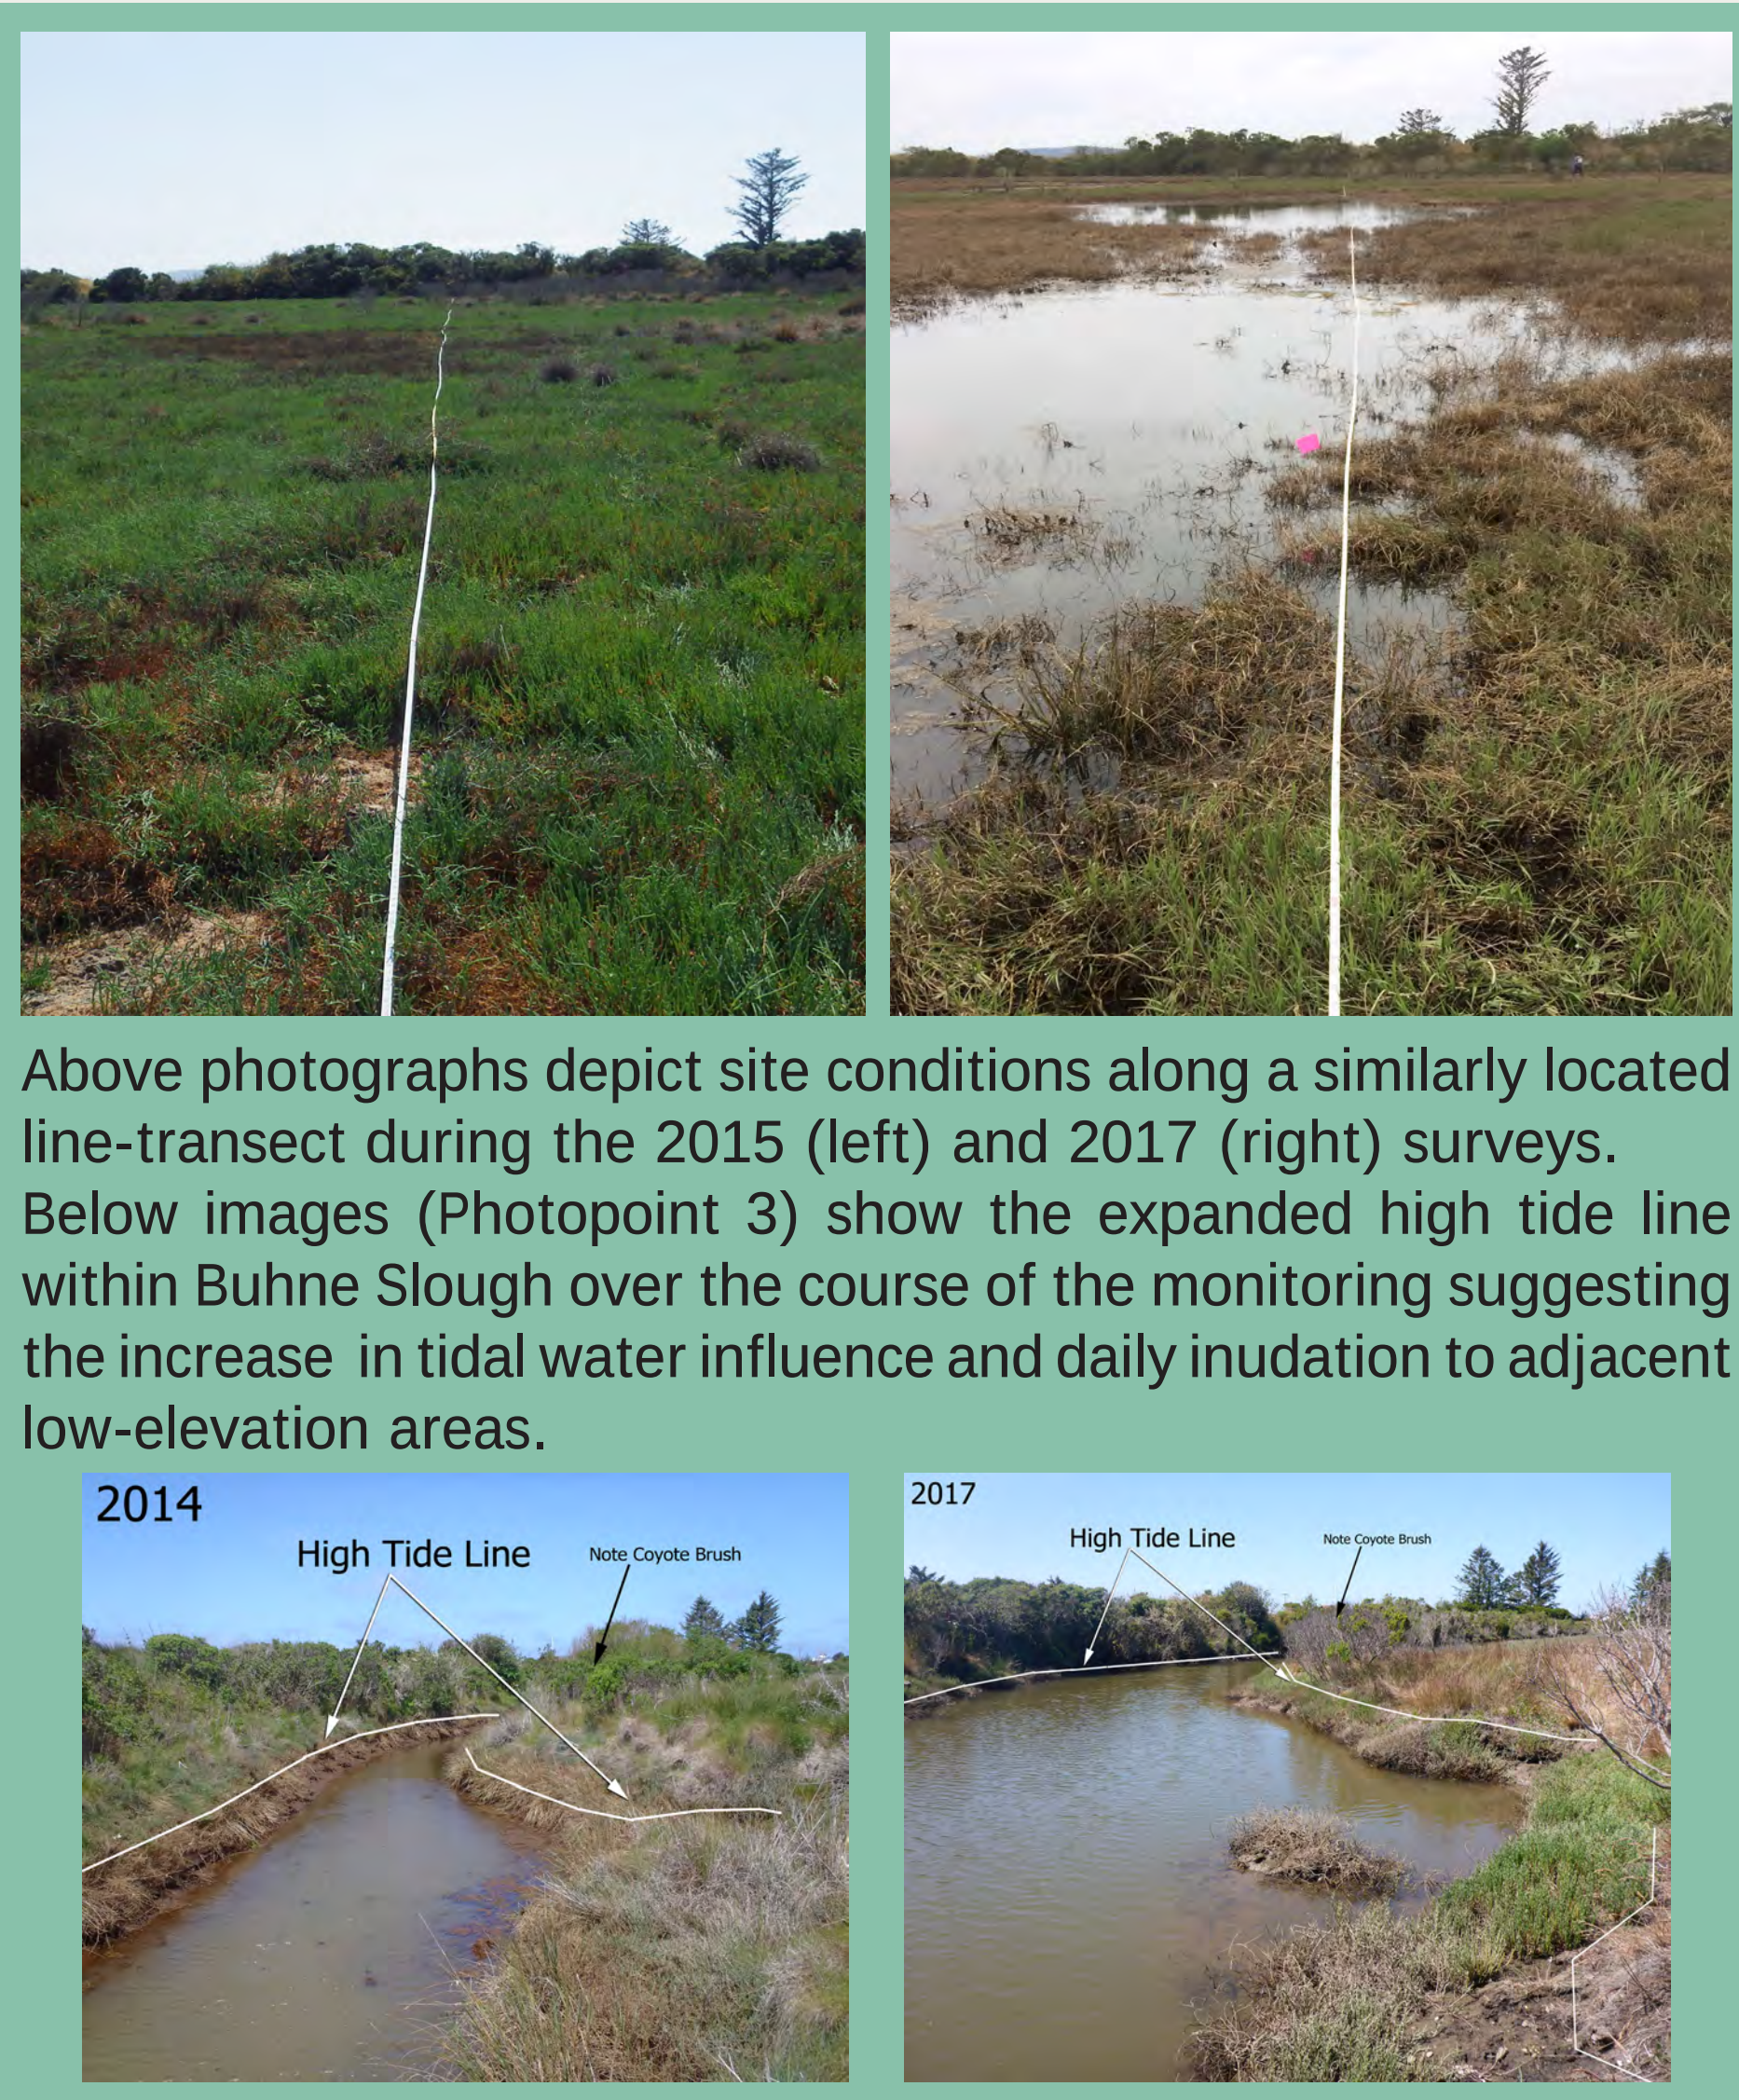
Above photographs depict site conditions along a similarly located line-transect during the 2015 (left) and 2017 (right) surveys. Below images (Photopoint 3) show the expanded high tide line within Buhne Slough over the course of the monitoring suggesting the increase in tidal water influence and daily inundation to adjacent low-elevation areas.

The 2017 data indicated a substantial decrease in overall relative cover for both emergent brackish marsh and emergent salt marsh species and concurrently an increase in cover from litter (mostly noted as *S. pacifica* and *D. spicata* dead plant material). The decline of emergent brackish marsh species and the mortality observed in coastal scrub species in 2016 was assumed to be related to increased salt water intrusion resulting from the failure of the tide gate between 2015 and 2016 monitoring periods. Cover results indicate the initial increase

in emergent salt marsh cover in 2016 was related to salt marsh species growth and recruitment in areas previously occupied by brackish marsh species as well as in areas of bare ground. The substantial decrease in salt marsh cover and consequent increase of litter in 2017 was suspected to be associated with the long-term (>1 year) change in daily hydrologic conditions (i.e., longer salt water inundation periods) in the marsh. These changed conditions are resulting in increased water level depth at inundation and greater waterlogging stress on established salt marsh species.

As the monitoring coincided with the failure of the adjoining tide gate and the consequent increased tidal inundation duration and extent within the survey area, these results are indicative of how quickly low-elevation coastal marsh landscapes respond to increased tidal influence. In 2019, the site was revisited during low-tide events and, based on visual inspection, a large portion of the survey area is now open mudflat where vegetation continued to die back. Future planning for preservation of coastal marshes in the region should evaluate marsh elevation to avoid conversion to open mudflat with increased tidal inundation and sea level rise.
