Restoring coastal grassland on deeply scraped soils in Monterey County, CA

Andrea Woolfolk, Mary Paul, and Bill Fortner
Elkhorn Slough National Estuarine Research Reserve

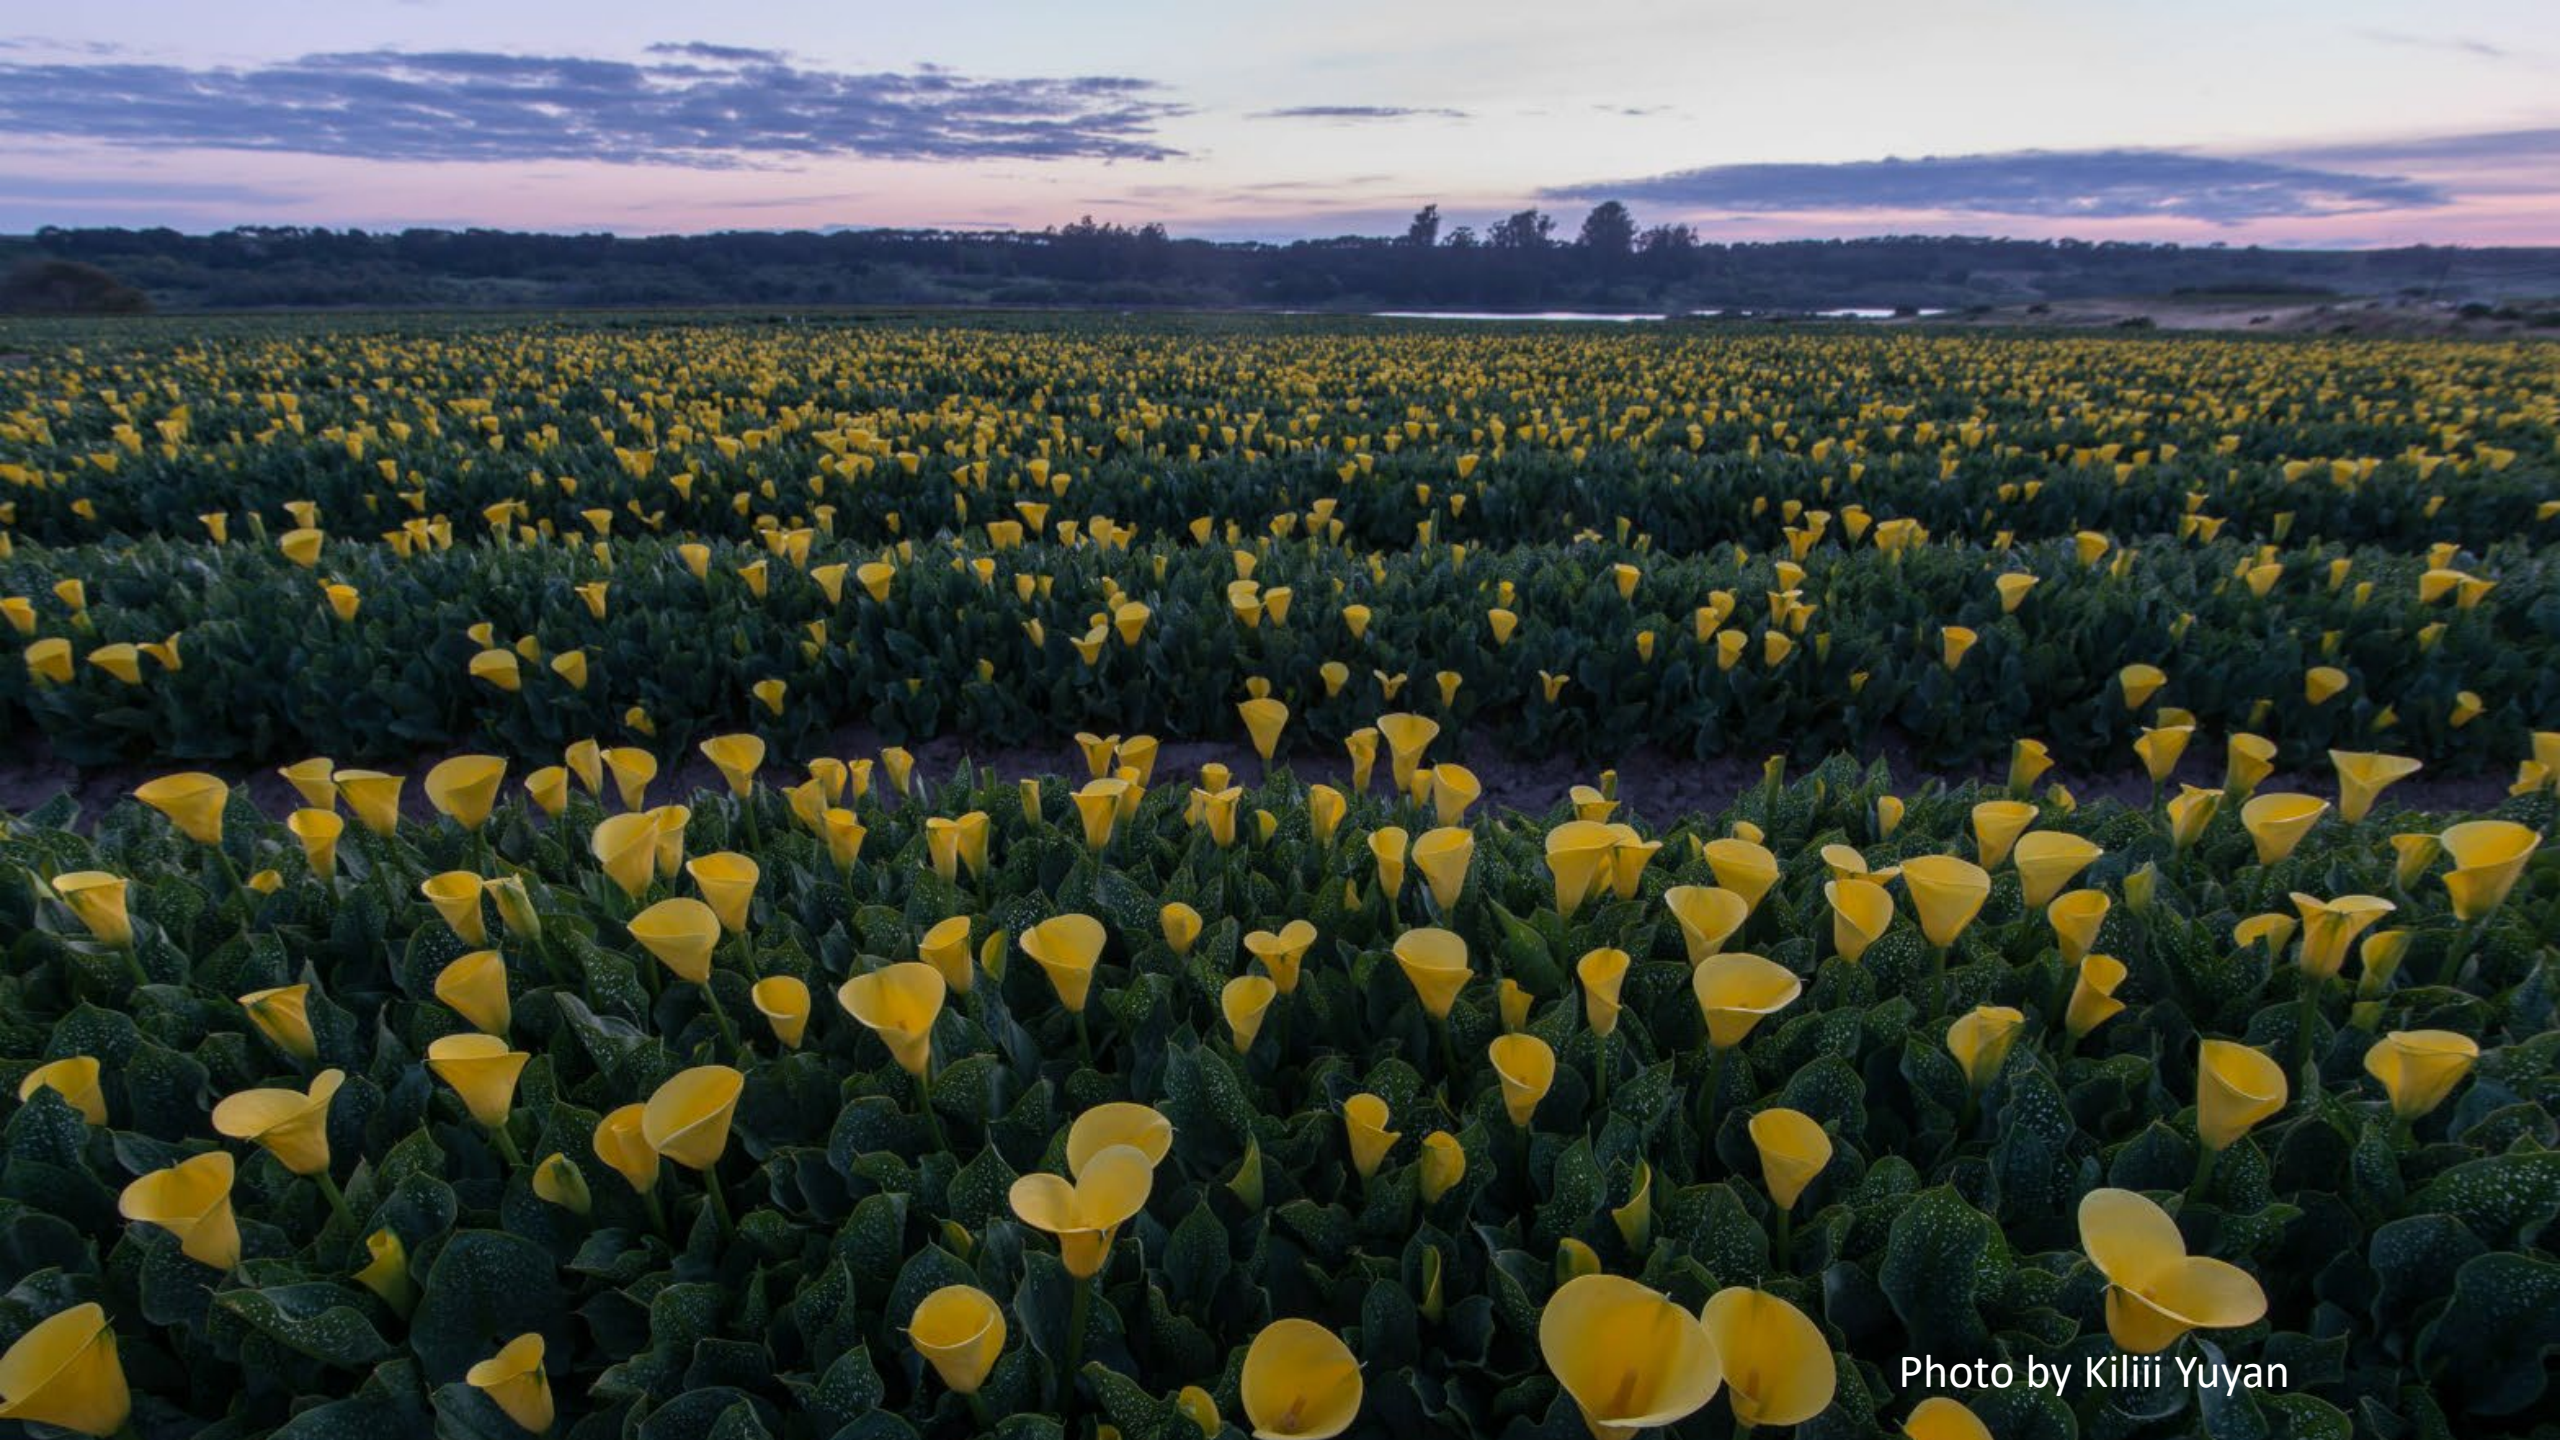
Former salt marsh at Hester:
converted to mudflat after diking and draining

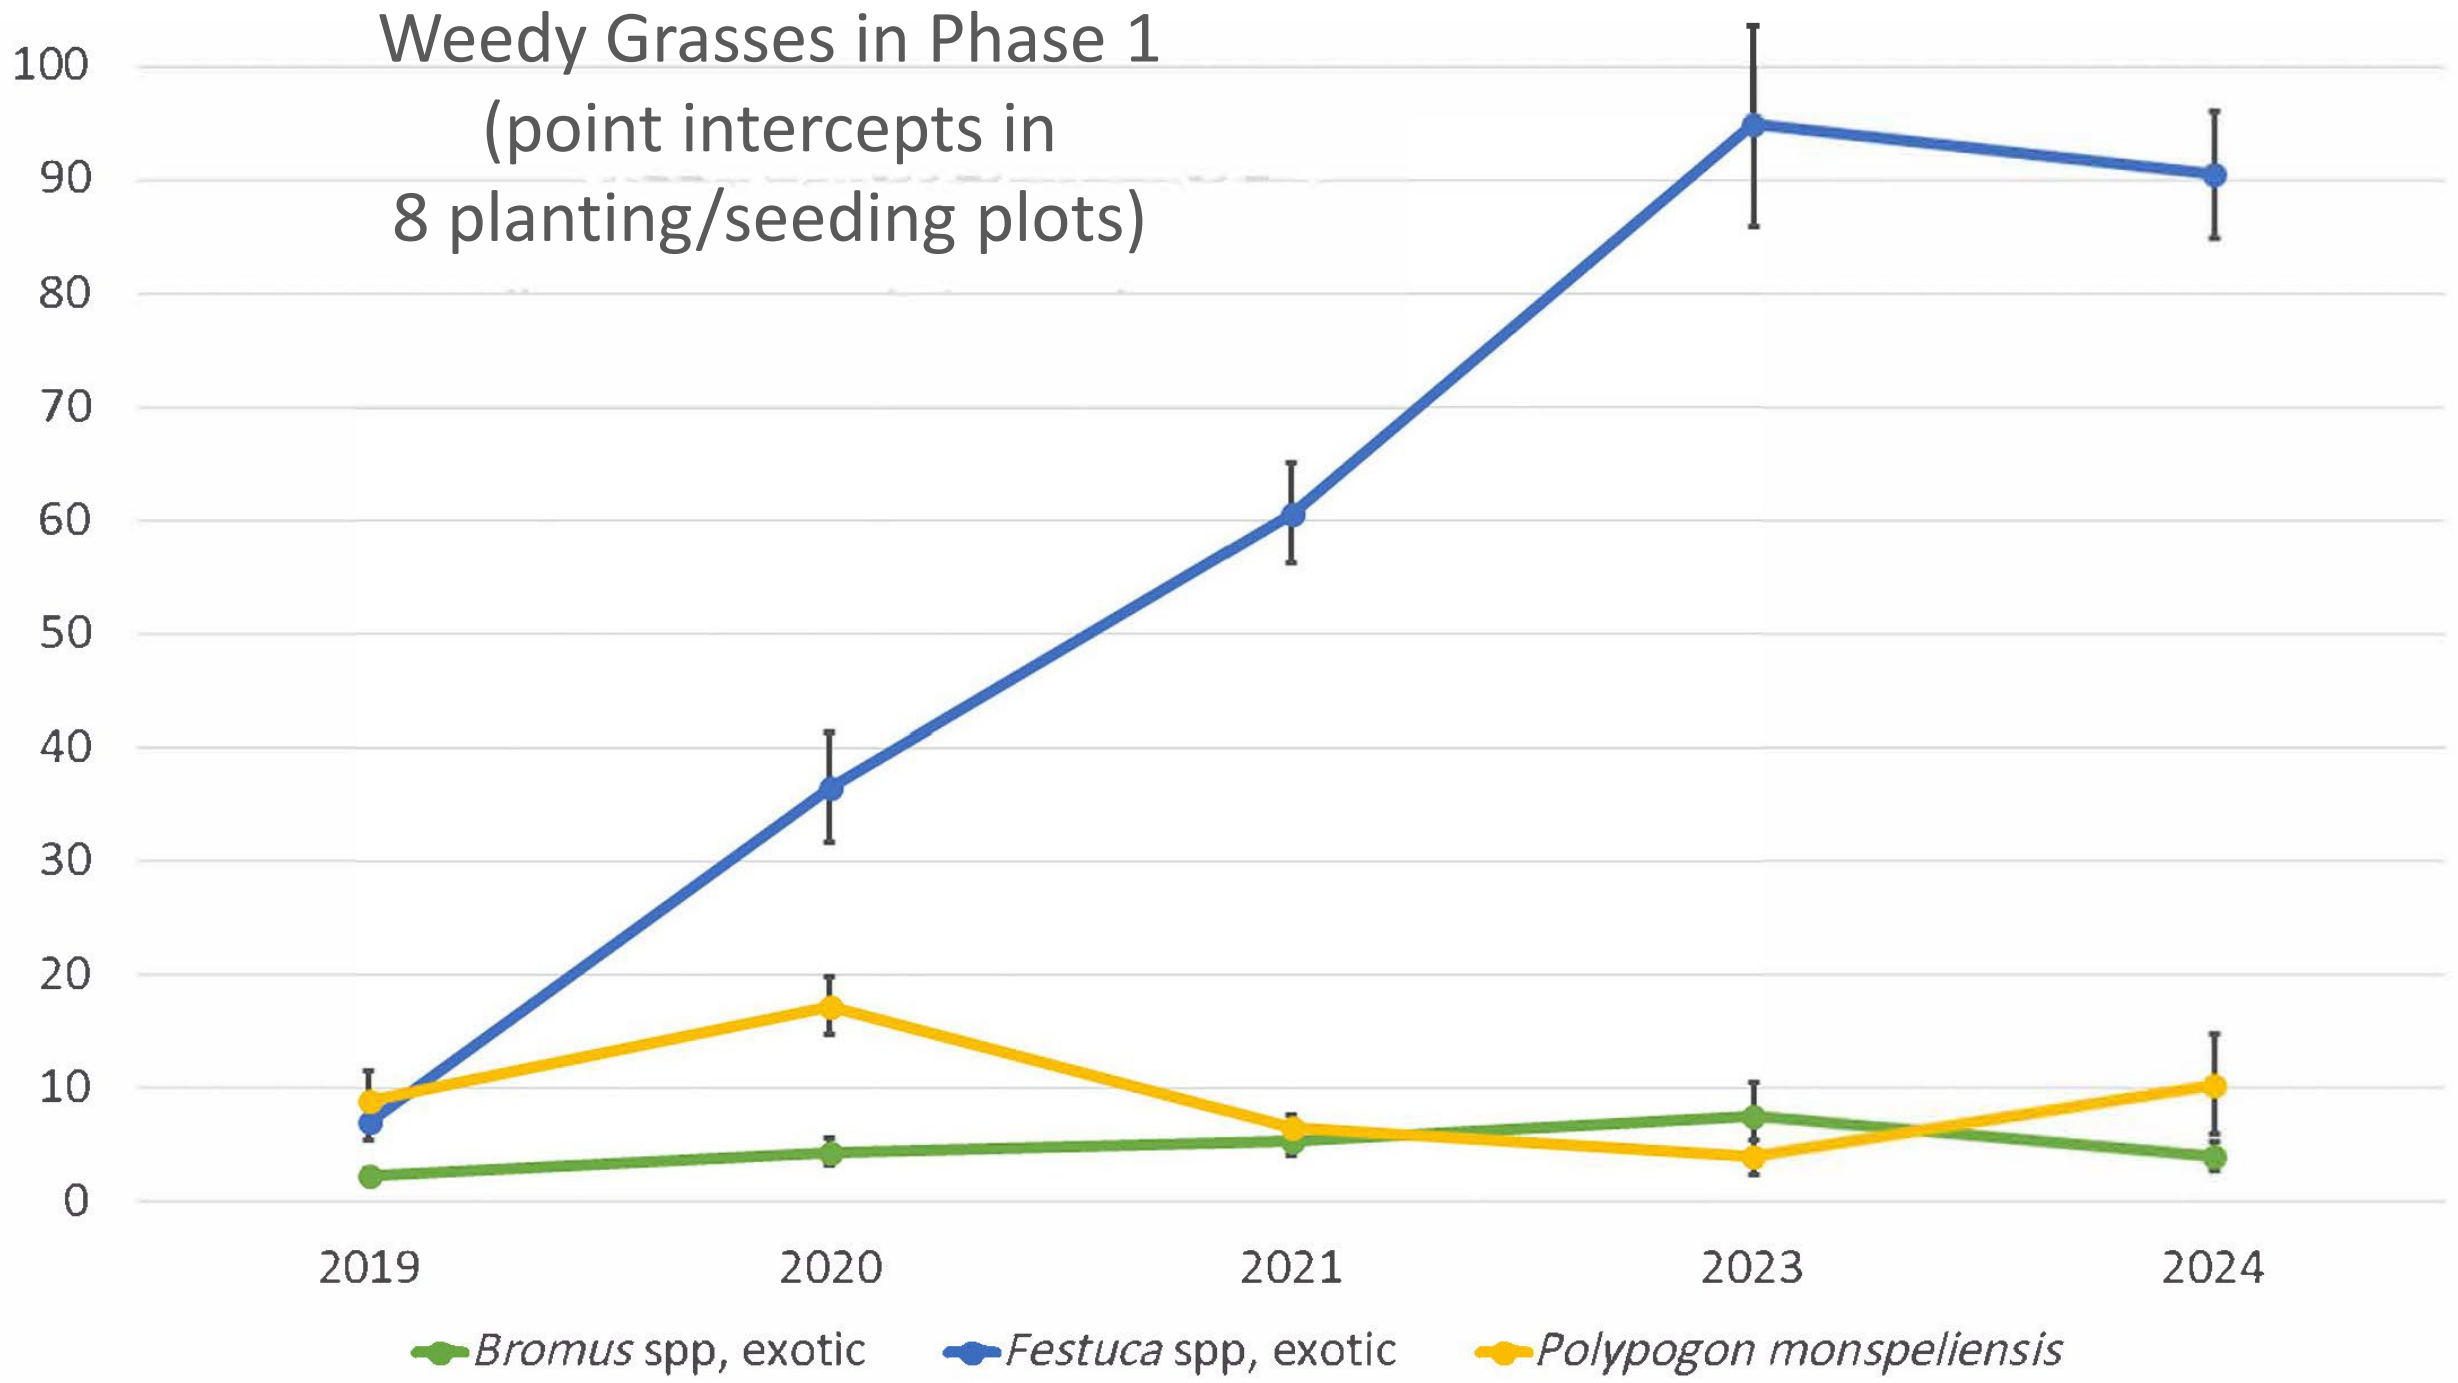
Weedy Grasses in Phase 1

(point intercepts in 8 planting/seeding plots)

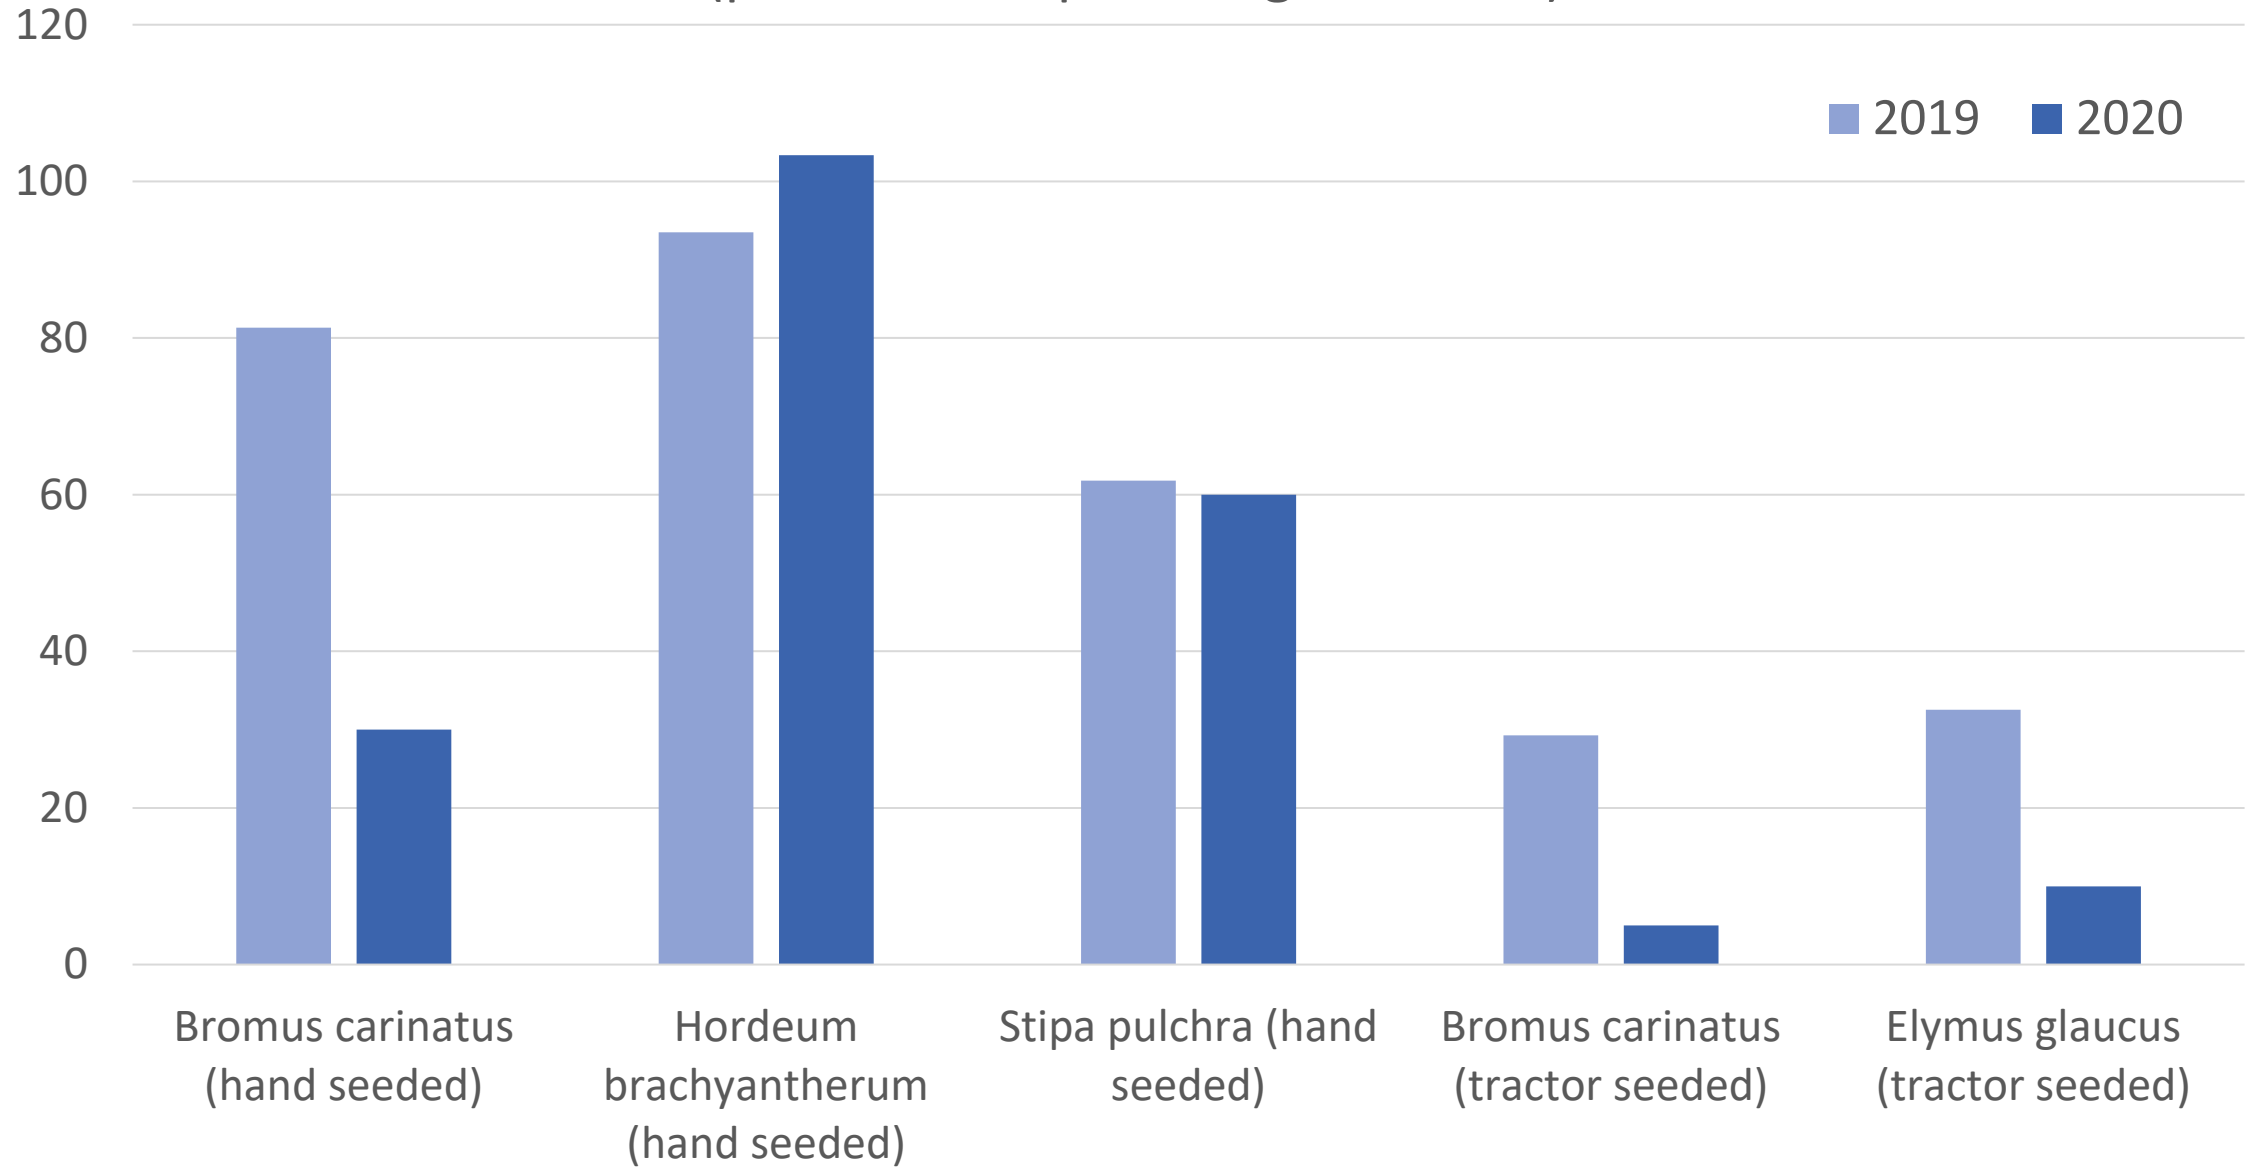
Phase 1 Area: Percent Cover of Seeded Grasses (point intercepts along transects)

We were surprised that our hand seeding did much better than the tractor seeding

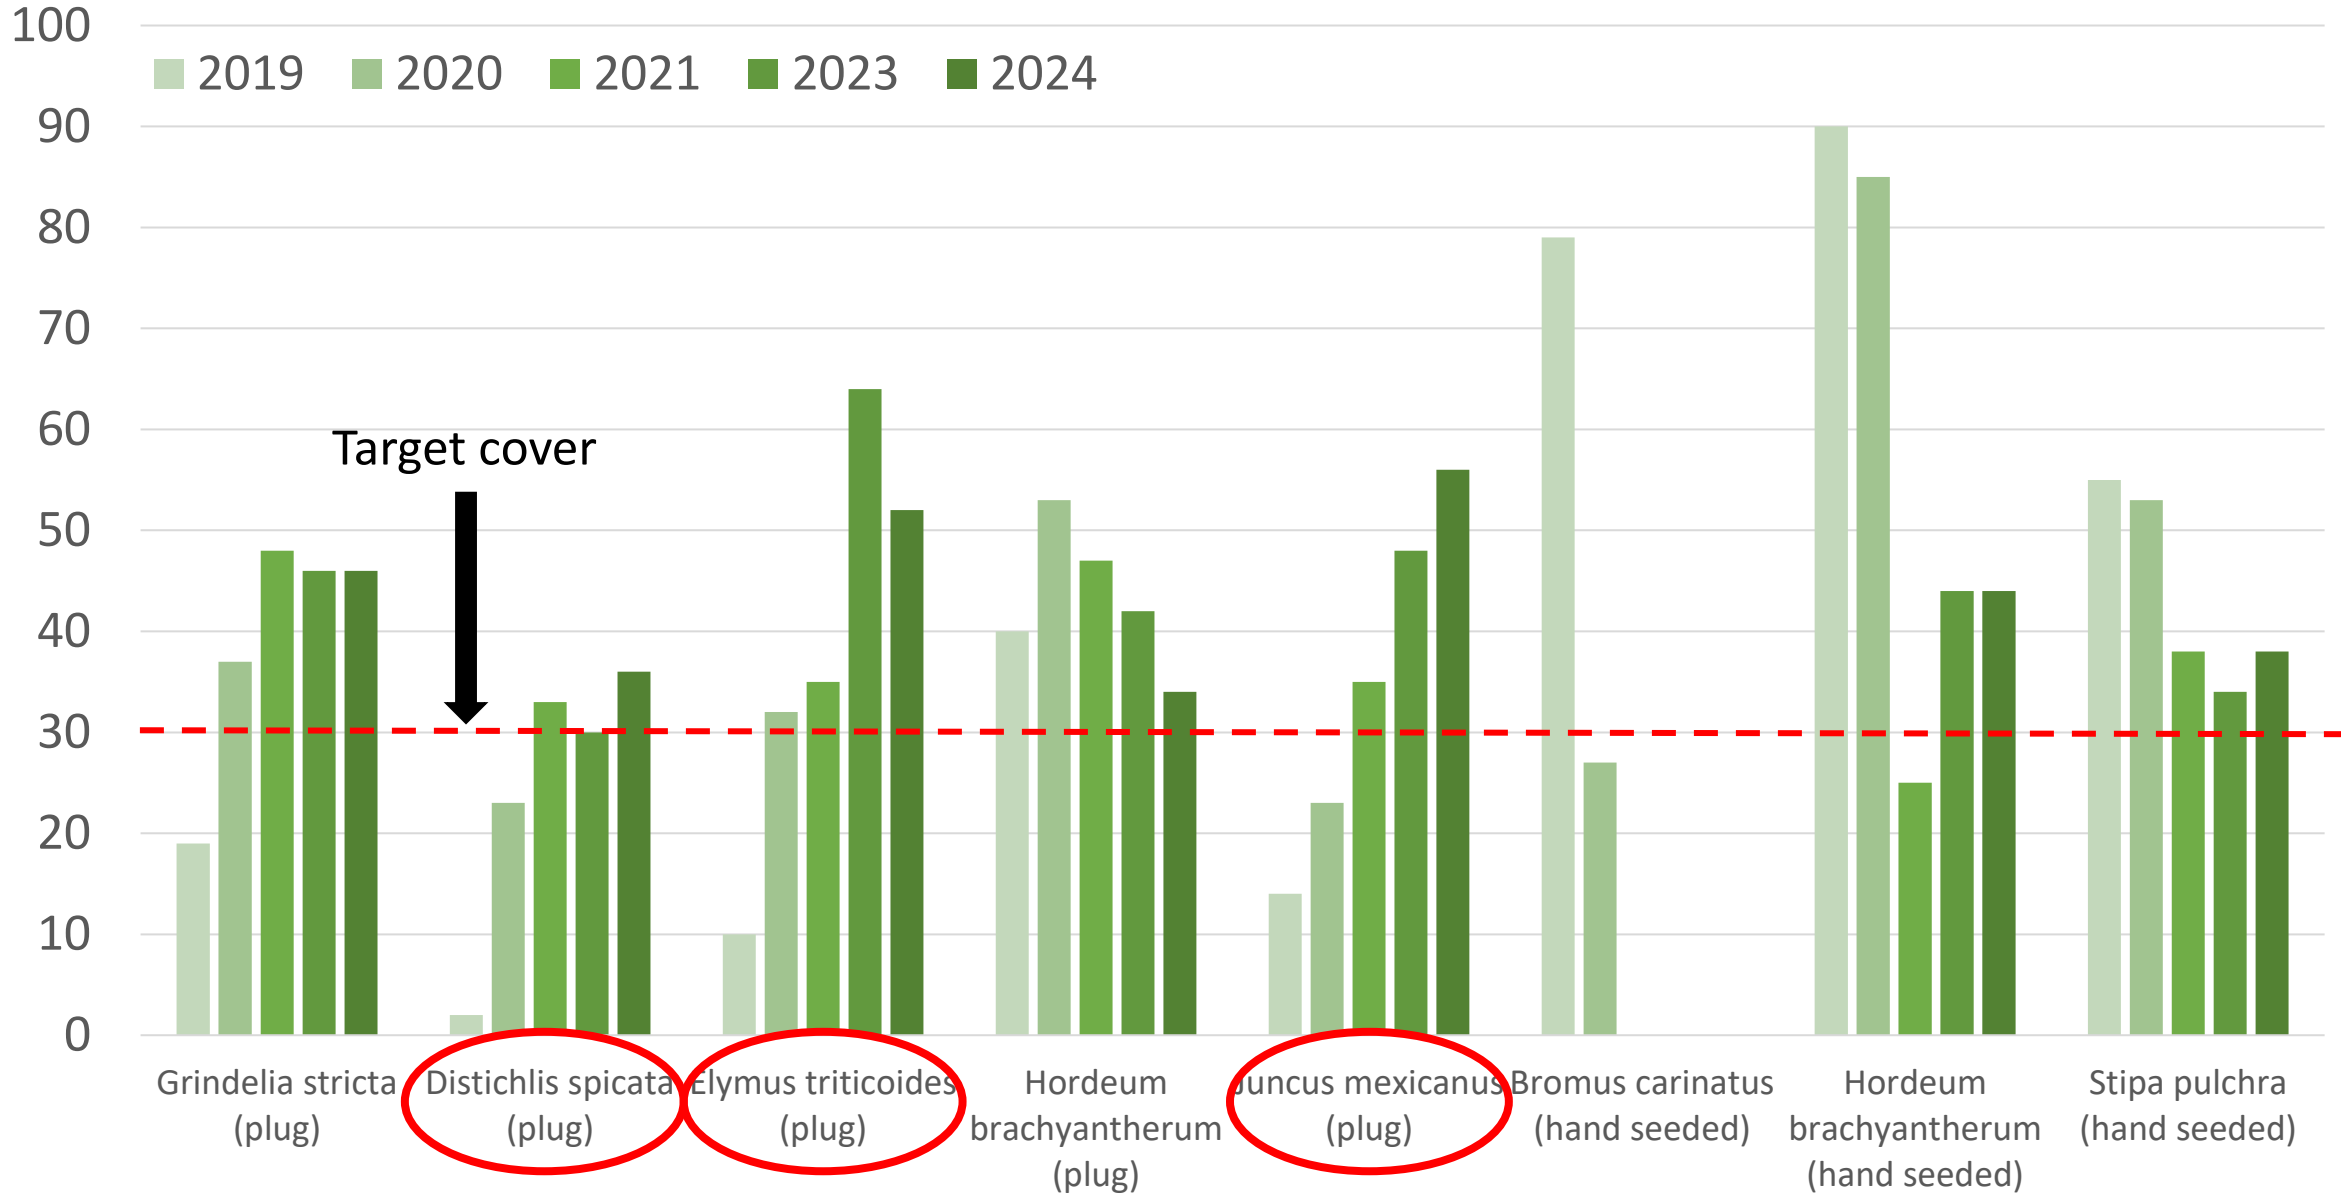
Phase 1 Area: percent cover of planted and hand seeded plants in single species blocks, 0.3-0.5 ac each (no data for 2022)

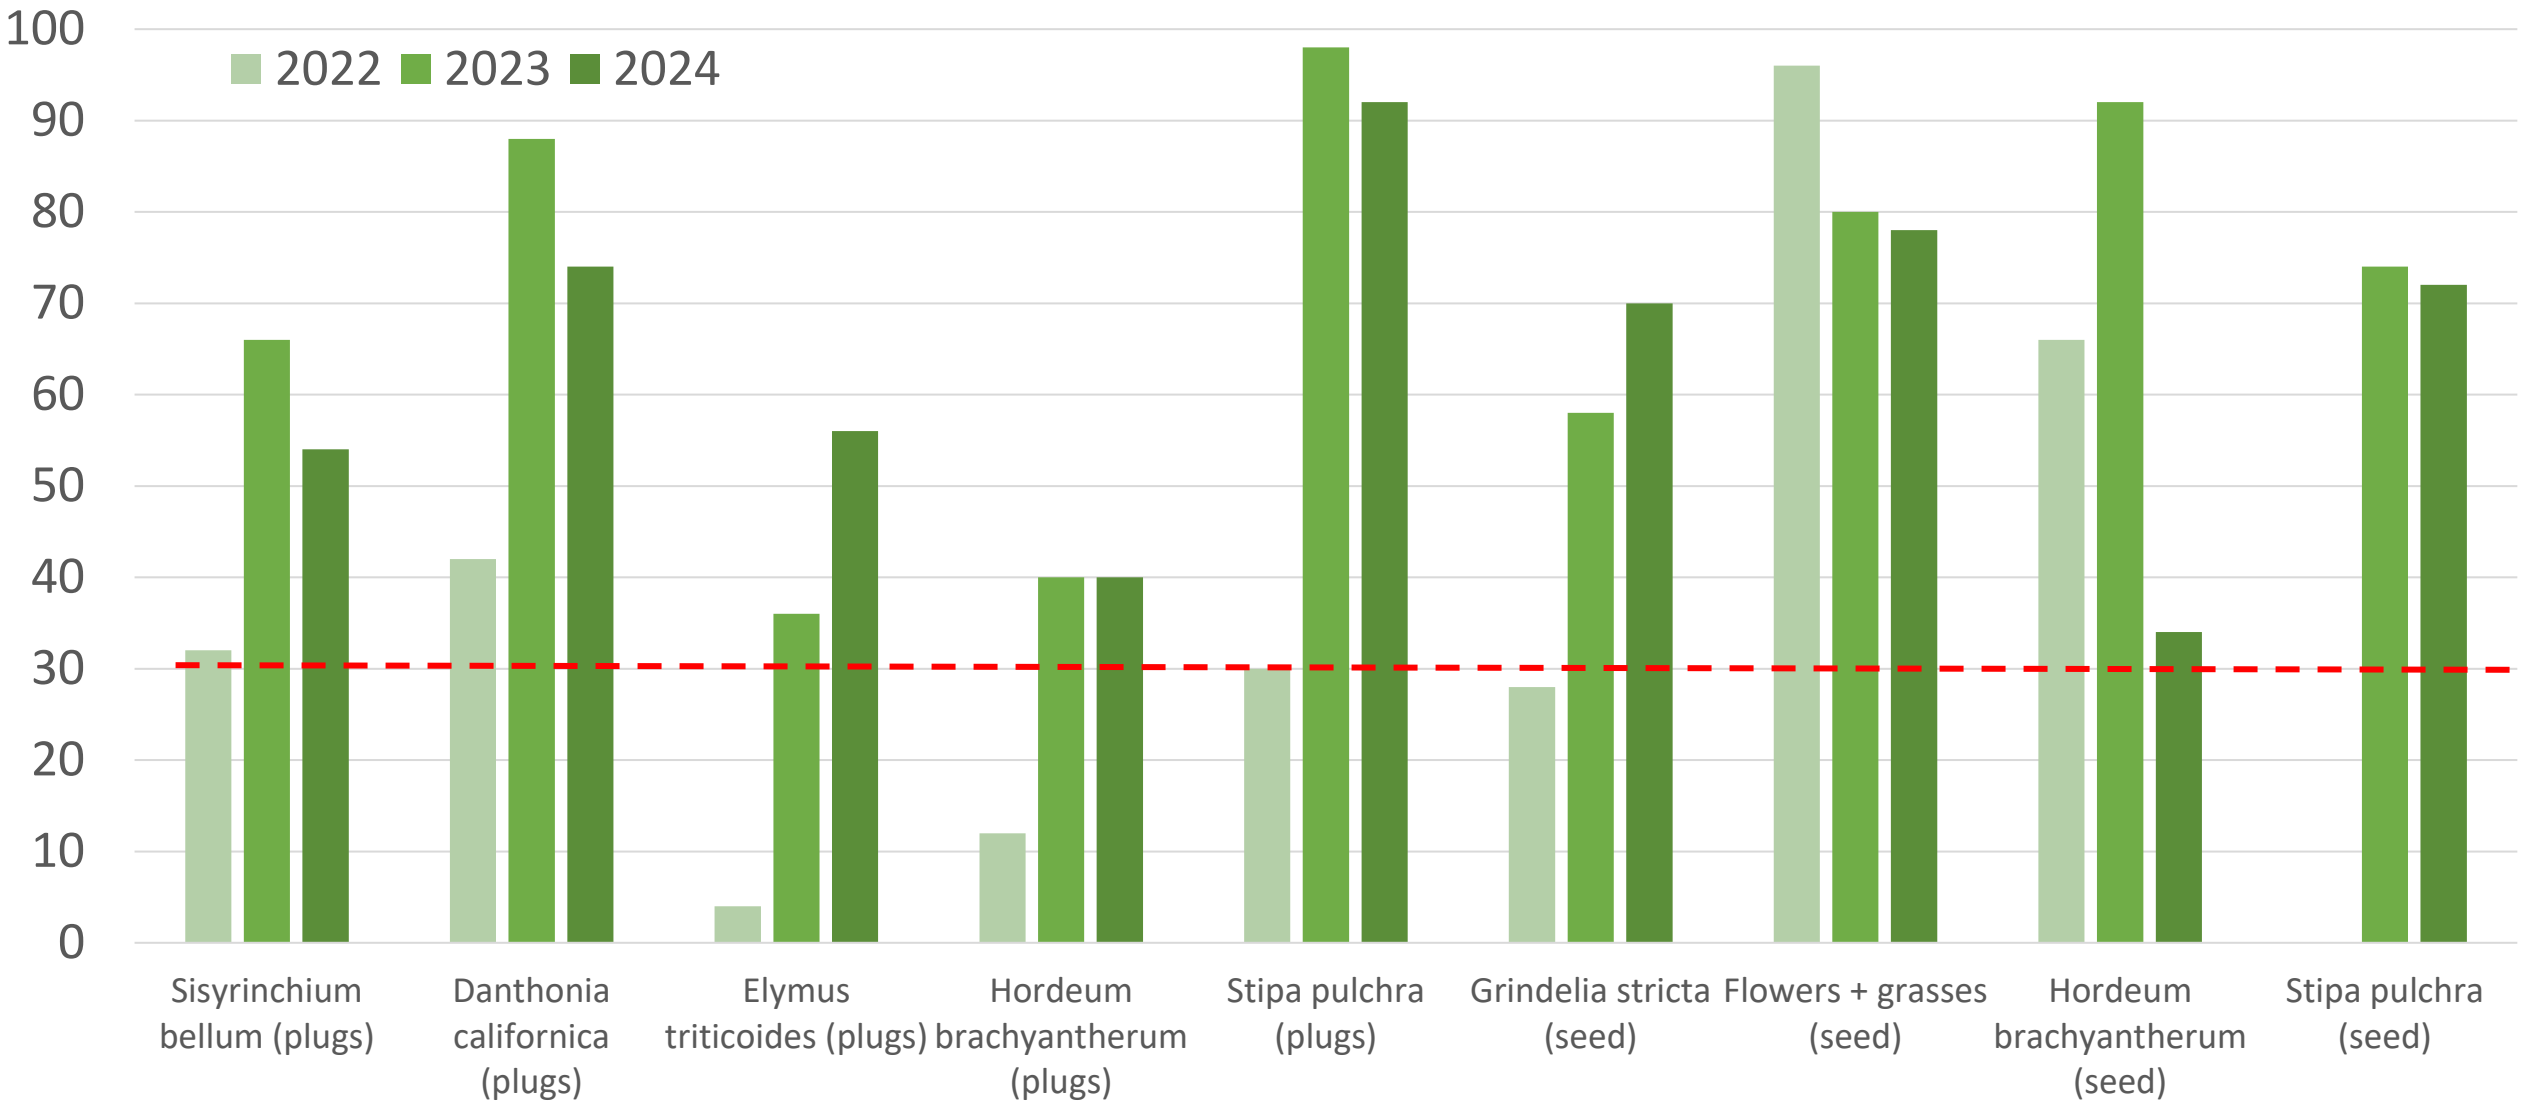
Phase 2 Area: Percent Cover of Target Native Plants

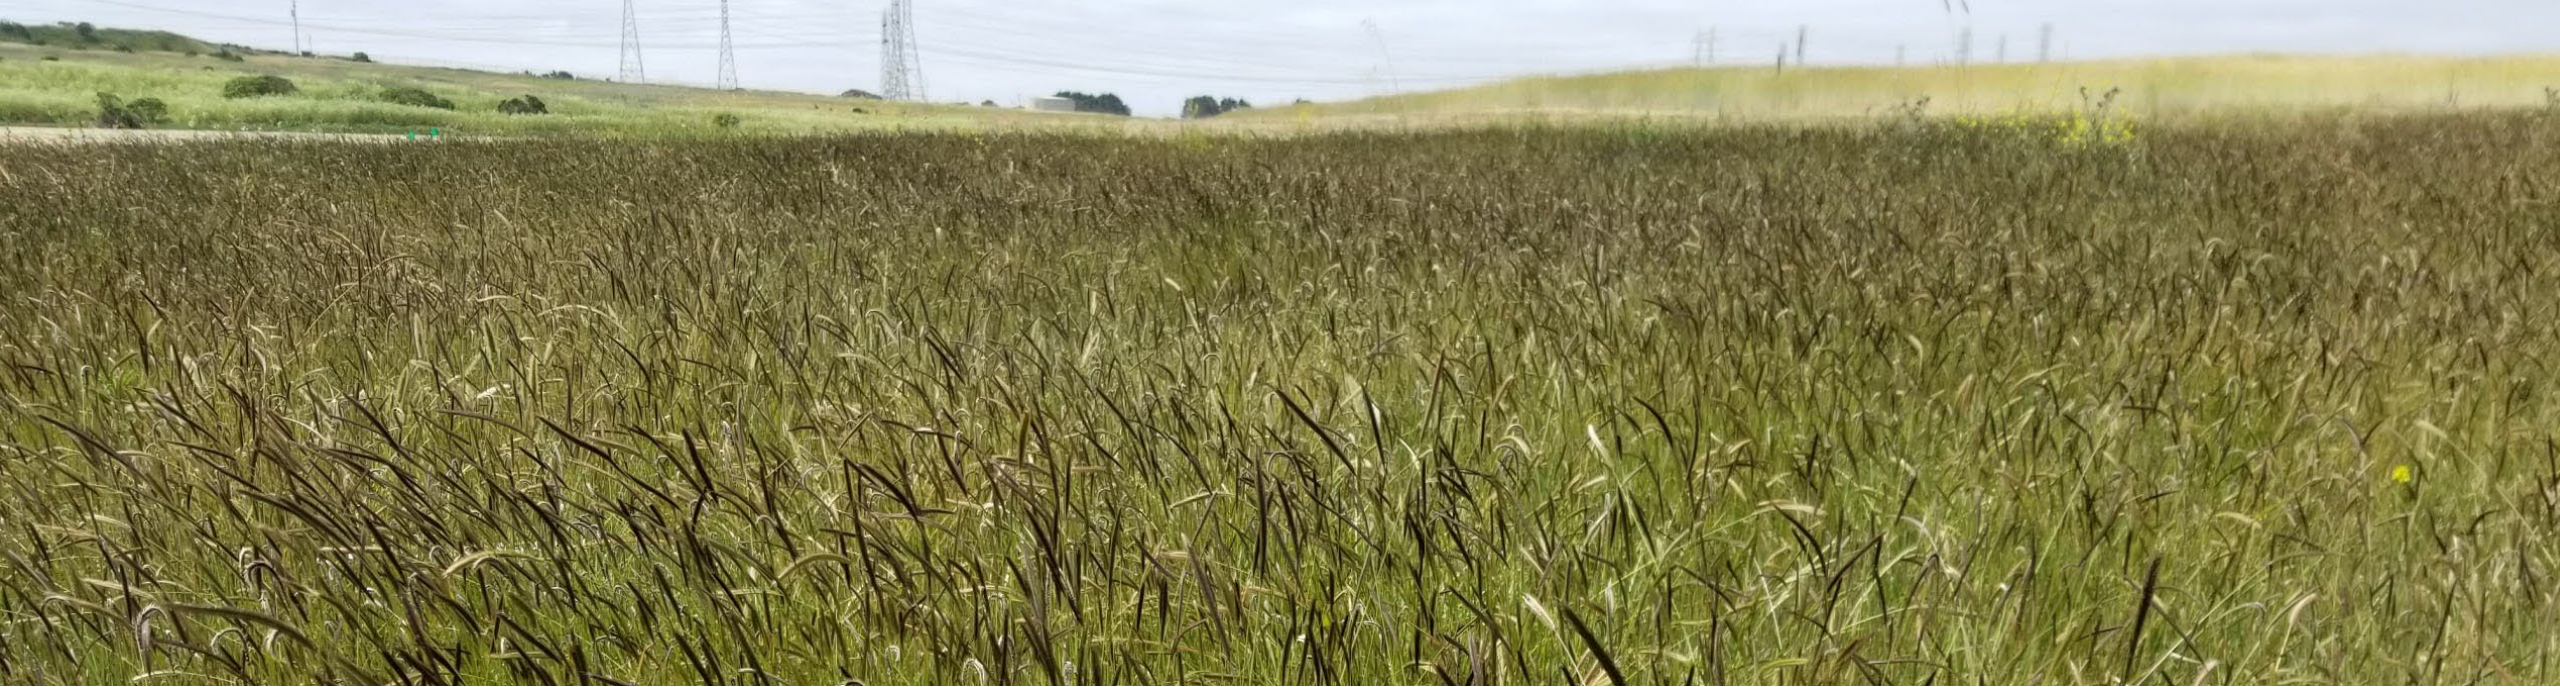
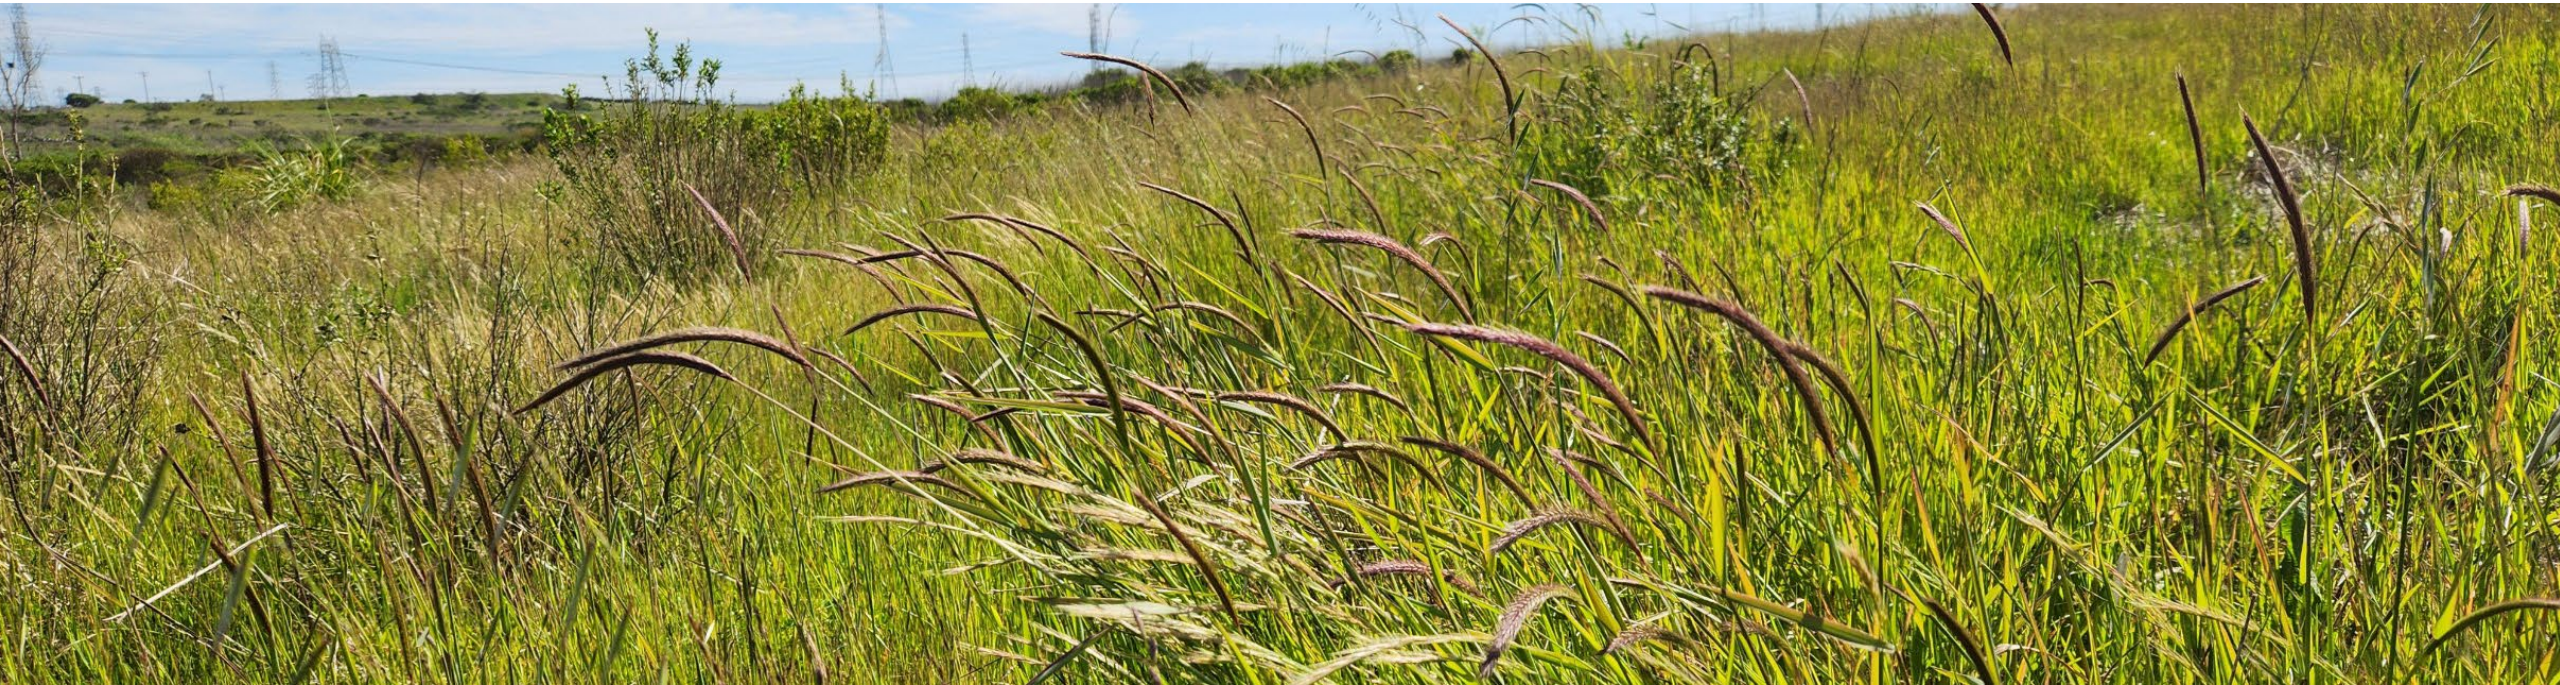
Things change. Seeded meadow barley in 2019 (above) and 2024 (below)

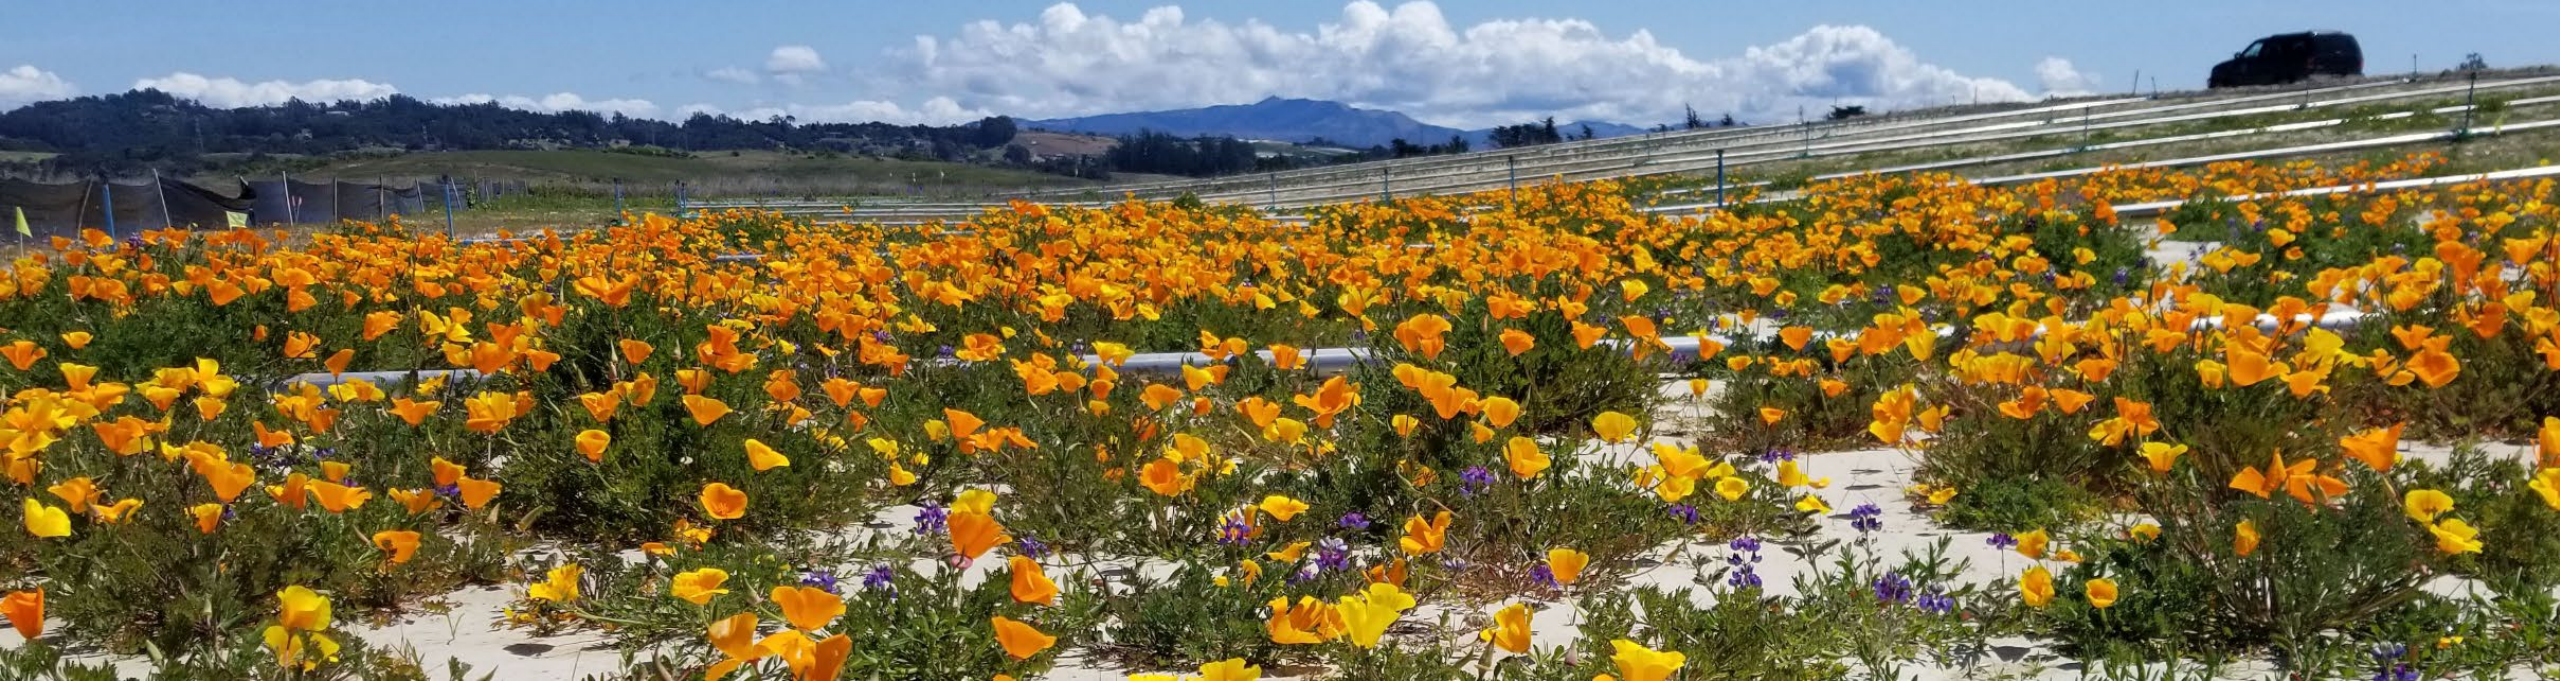
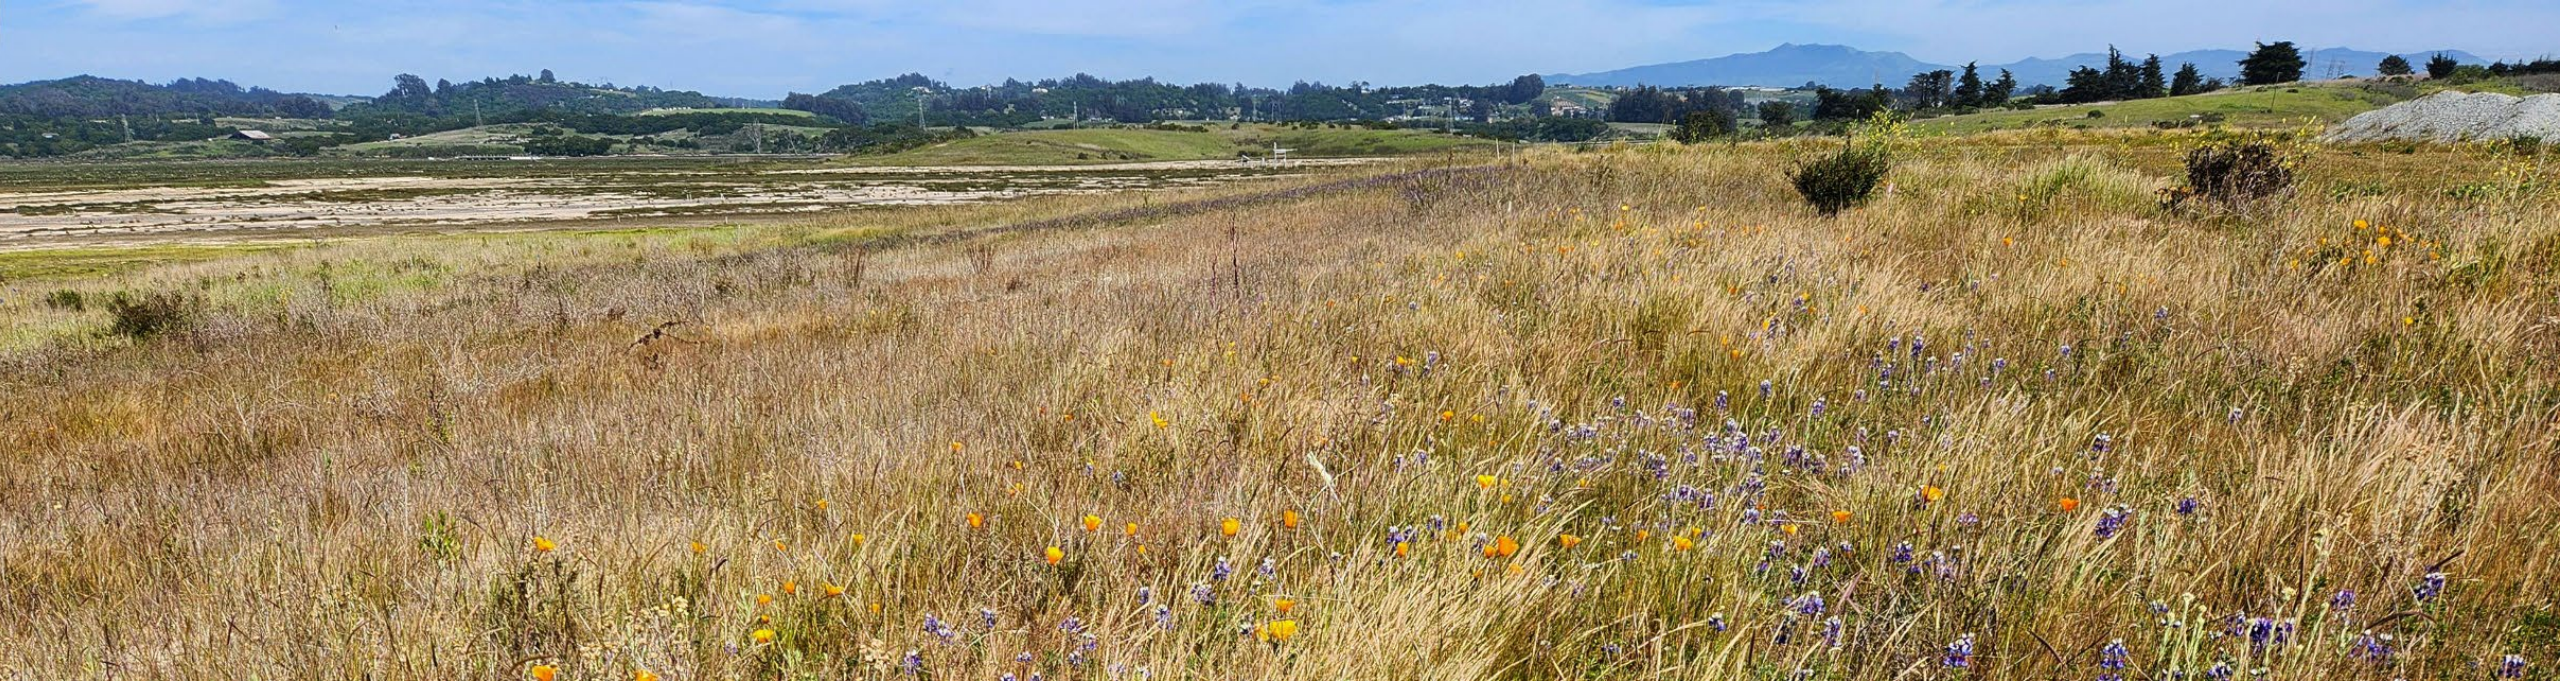
2022 (above) with 64% cover of CA poppies & 2024 (below) with 2% CA poppies, 76% native grass
