Restoring coastal grassland on deeply scraped soils in Monterey County, CA

Andrea Woolfolk, Mary Paul, and Bill Fortner
Elkhorn Slough National Estuarine Research Reserve

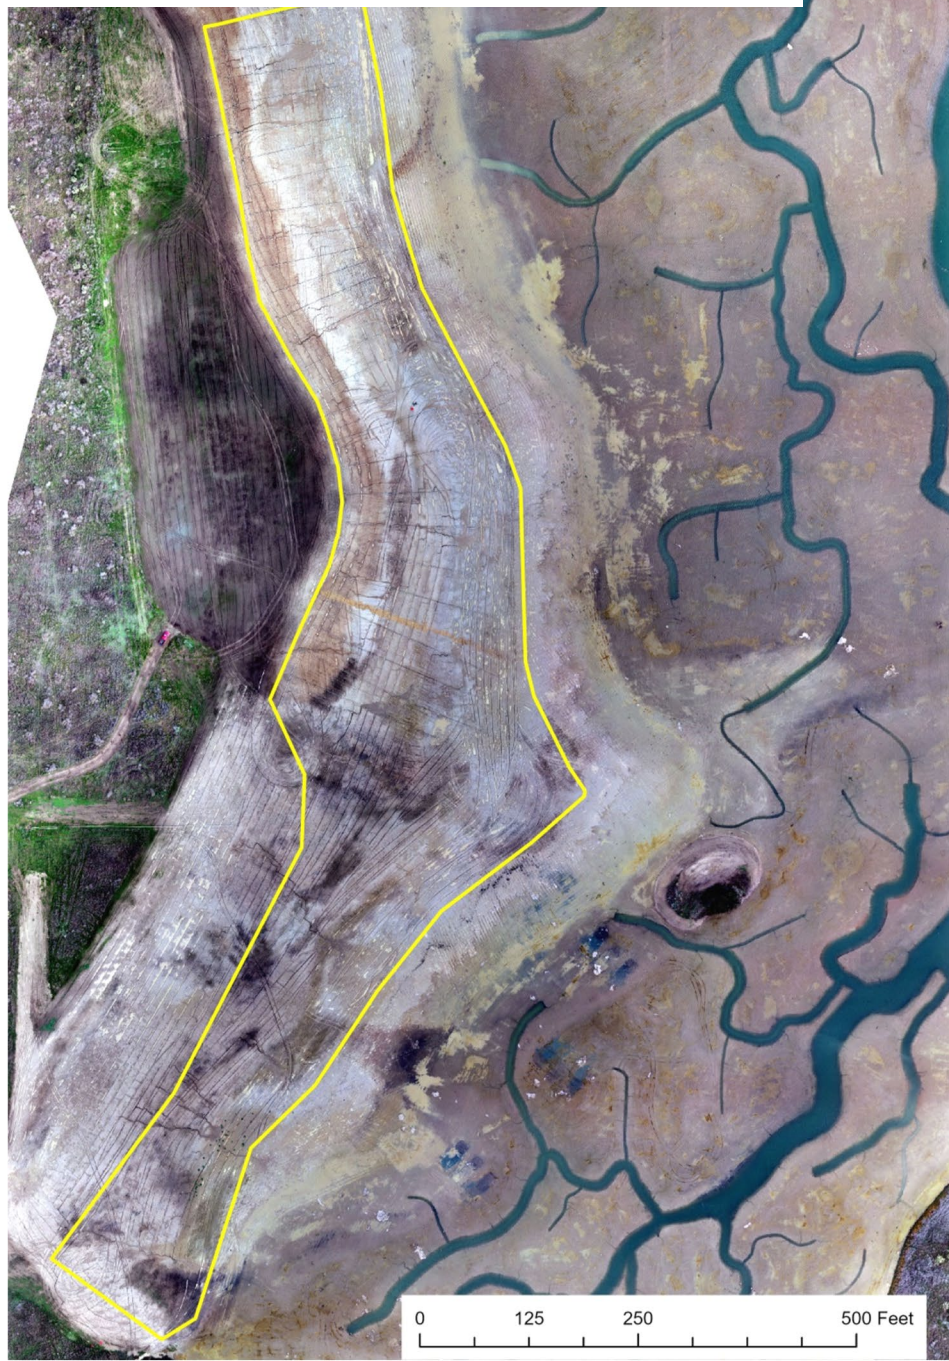
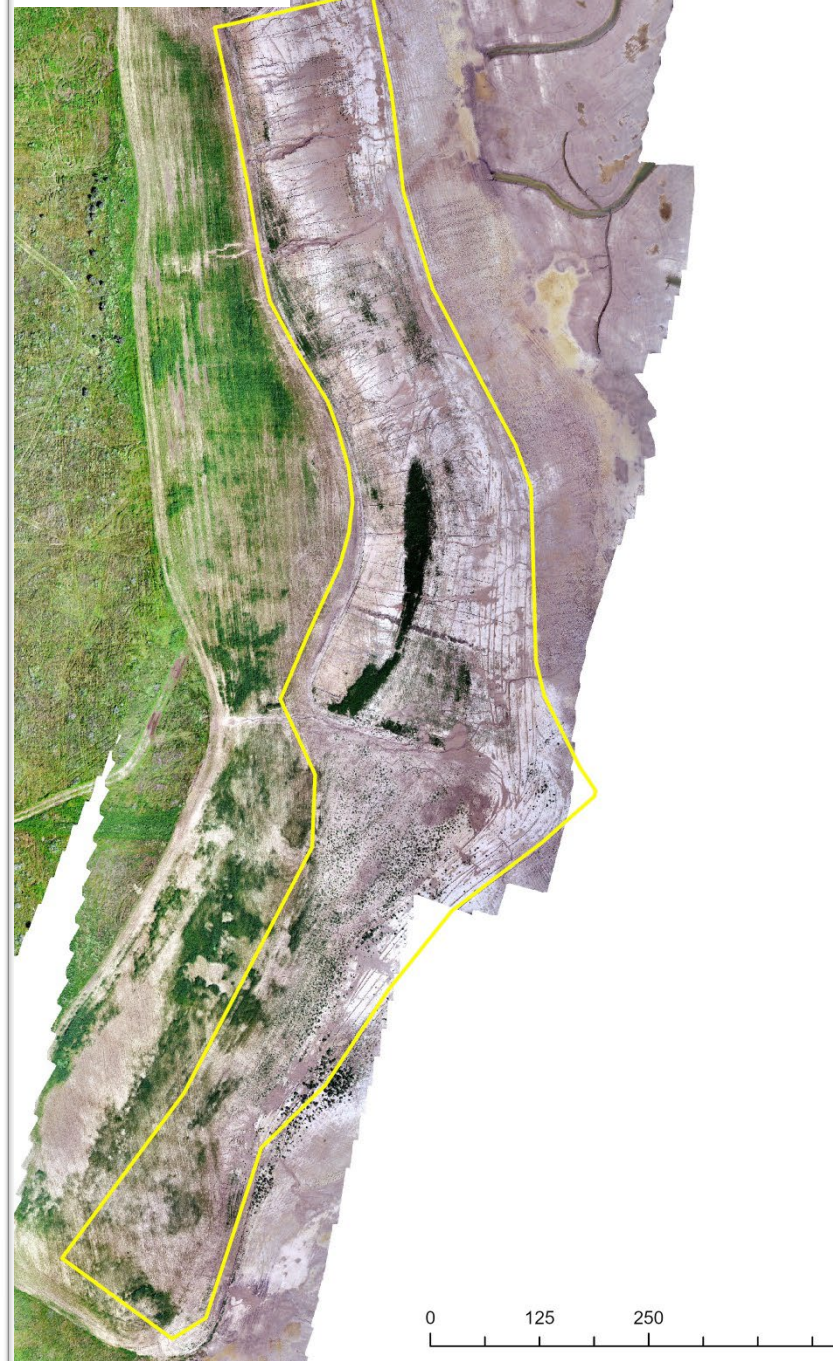
2009 before project

December 2018 – excavation complete

March 2019

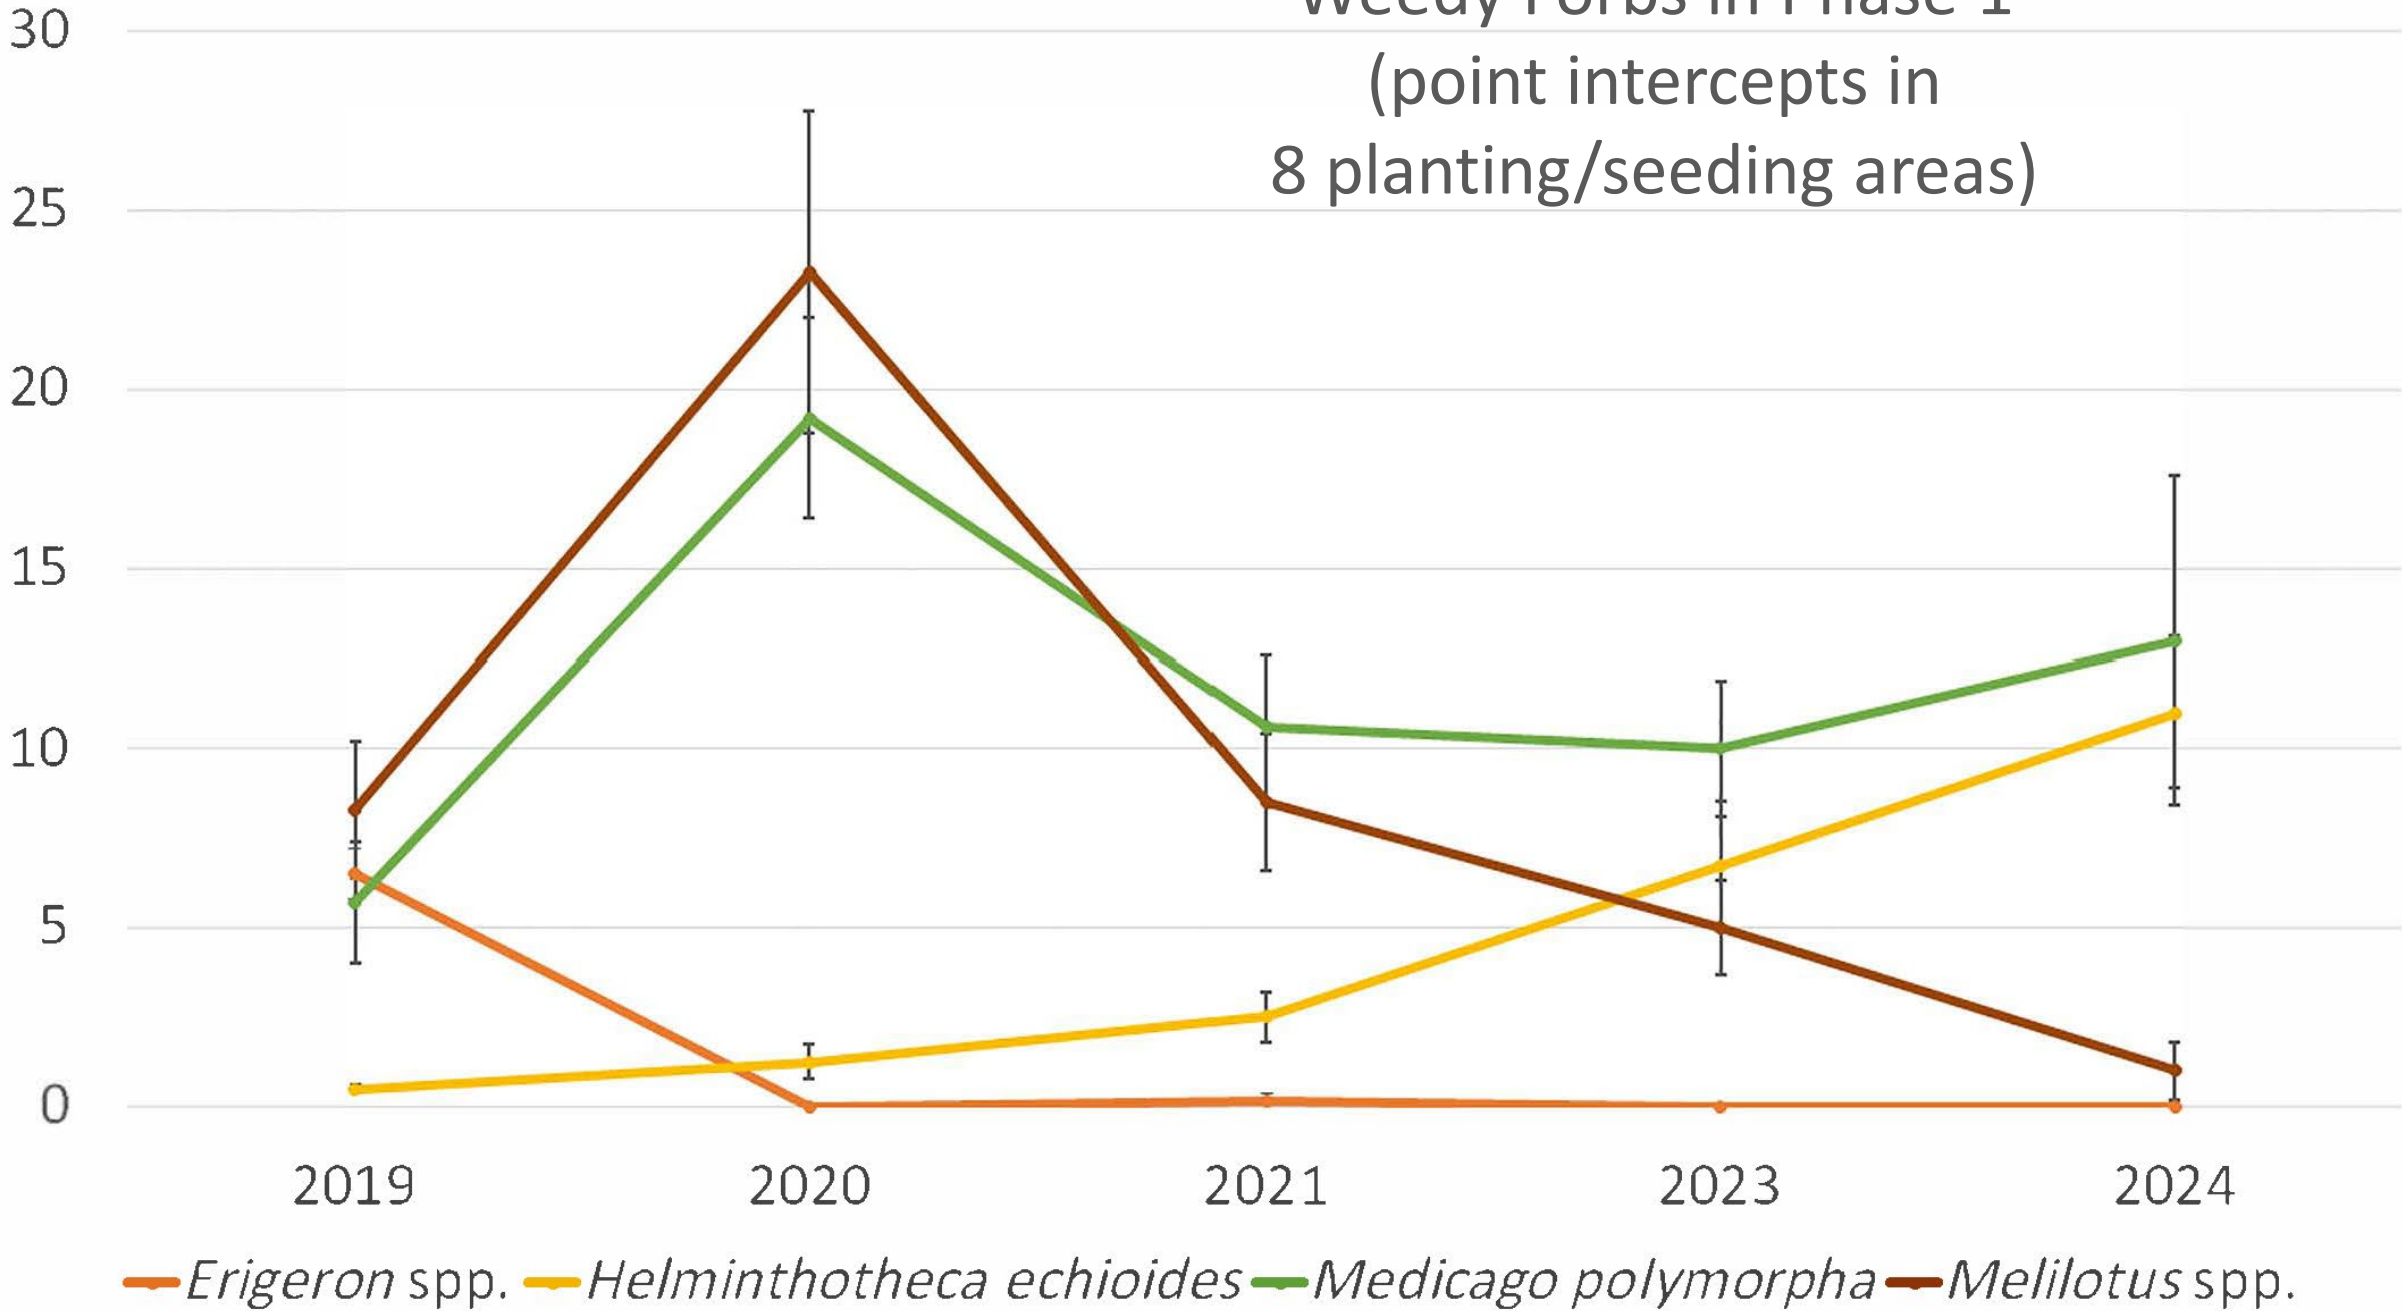
Weedy Forbs in Phase 1
(point intercepts in
8 planting/seeding areas)
